**Remarkable historic timber roofs. Knowledge and conservation practice.
PART 1 - Construction history and survey of historic timber roofs**

TEMA
Technologies
Engineering
Materials
Architecture

**Remarkable historic timber roofs. Knowledge and conservation practice
Part 1 - Construction history and survey of historic timber roofs**

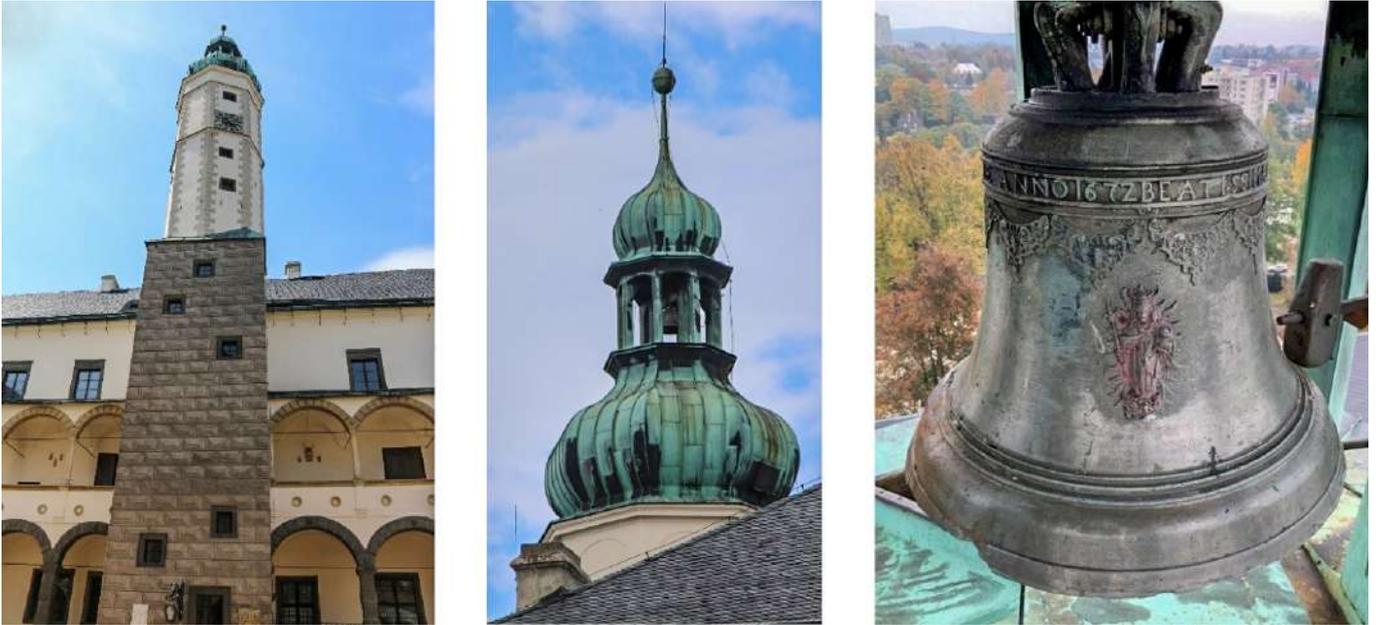
Fig. 3. Castle Bruntál, Clock Tower elevation, the roof of the Clock Tower, Bell with the bas-relief of Our Lady in the Clock Tower. (Photos by the Author, 2020).

The Clock Tower (Fig. 3) is part of the northwestern wing of Castle Bruntál. It extends the ground plan of the wing into the castle courtyard. The ground plan of the bottom part of the tower is rectangular, while the top part forms an octagon. The roof of the tower is formed by two onion domes and a lantern located between them. The bottom onion dome continues into the plated lantern and the top onion dome. In the lantern, there is a fixed bell in a static position and a bell of 1672 with colored relief of Our Lady, cast by Johan Grosch in Nysa [8]. The top onion dome continues into a finial with a circular tin case. The bottom part of the tower is lined with stones mostly; the upper floors are usually lined with bricks. There is a half-timbered structure in the top part of the tower, the timber parts of which are made of spruce, fir, and larch [6]. The timber framework is located on two top floors of the brick part of the tower and was placed on the inside face (Figs. 3 and 4). The structure is formed by wooden frames and St. Andrew's crosses between them (Fig. 5). The bottom part of the structure is composed of standard beams. The St. Andrew's crosses are located in the top part, below the roof truss. The elements are connected with woodworking joints with pegs. Thus, the half-timbered structure can be seen inside only. On the top floor of the brick part of the tower, the timber framework con-

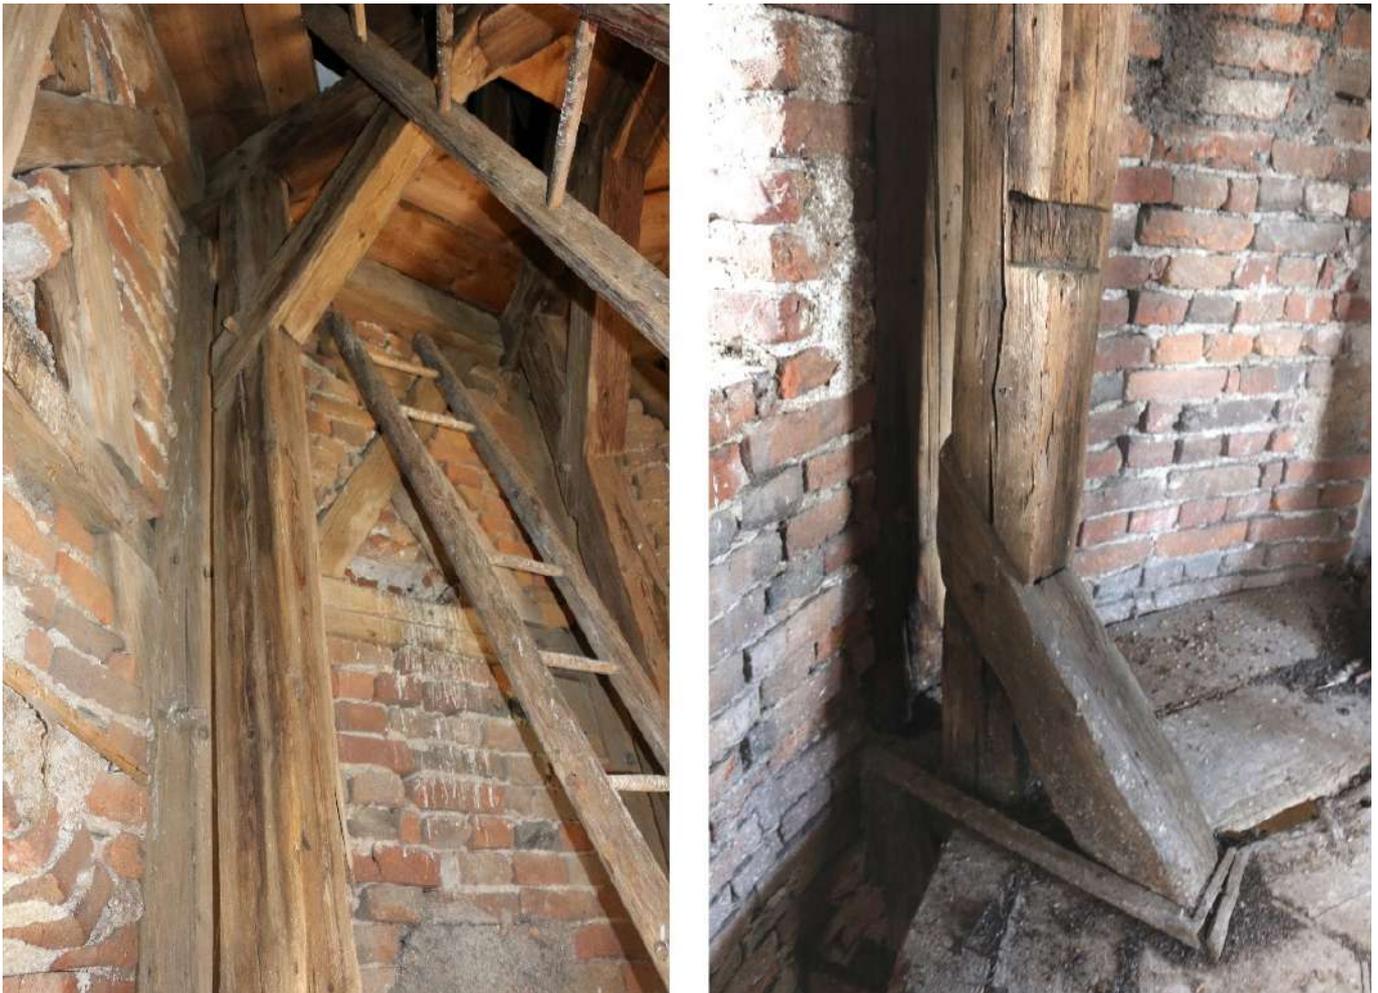
Fig. 5. Clock Tower, half-timbered construction, the traces of the older timber construction. (Photo, 2020).

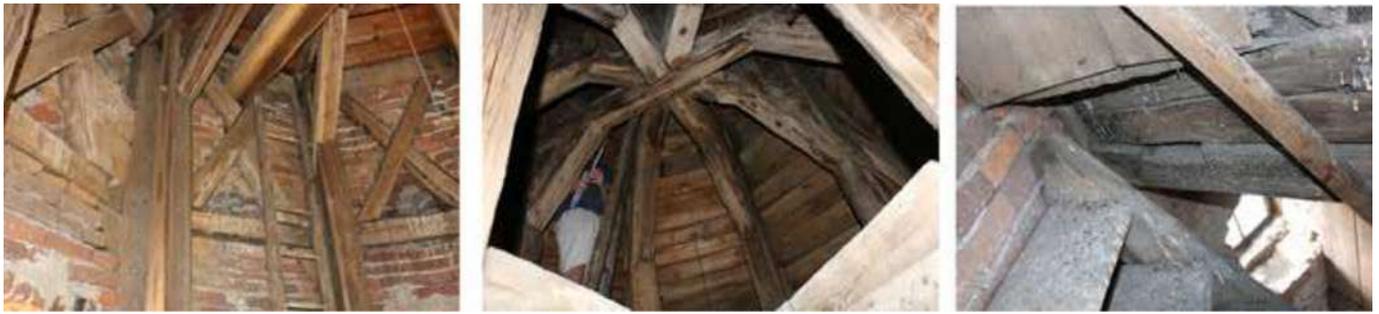
Fig. 6. Clock Tower, half-timbered construction, timber construction in the tower, the traces of the older timber construction, photo, 2020.

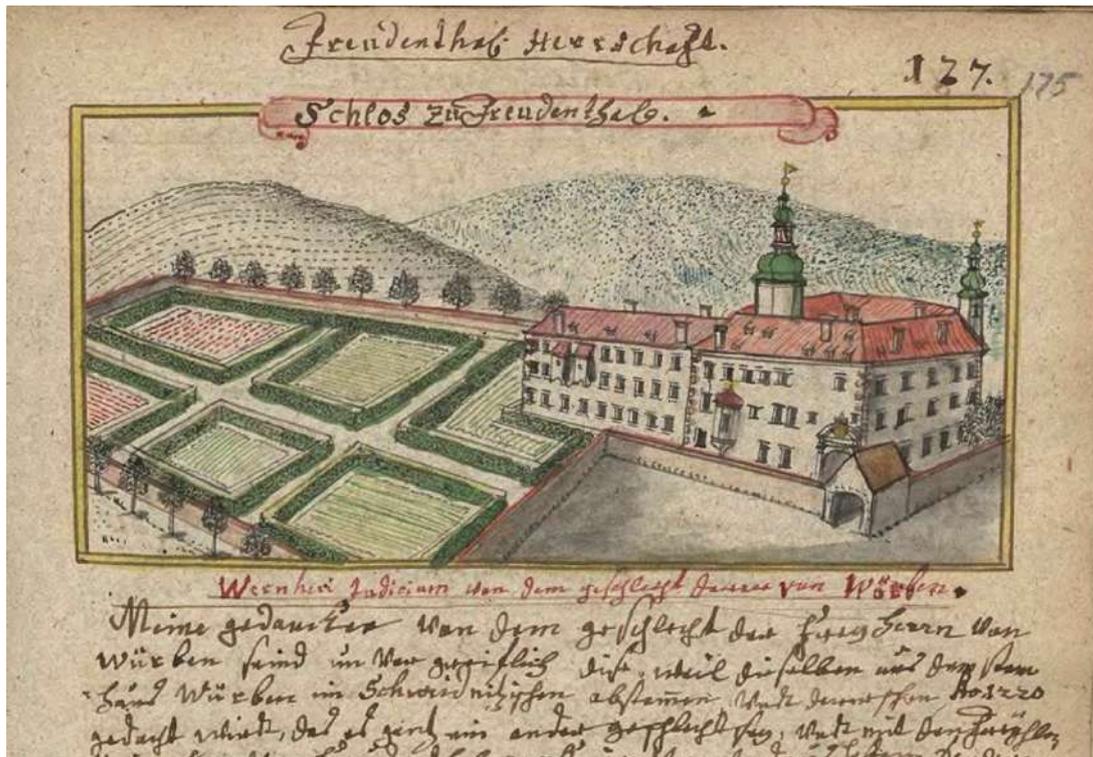
Fig. 8. F.B. Werner, Castle Bruntál. (Drawing, 18th century, Biblioteka uniwersytecka Wroclaw).

Two vedutas by Friedrich Bernhard Werner from the first third of the 18th century are a precious source of information on the development of the castle (Fig. 8). These vedutas have been preserved in the form of hand-drawn replicas from 1763 [12]. The time relationship between the shape of the roof truss and Werner's vedutas is not very straightforward. The drawing has red roofs of the castle and green tower domes. The report from the Teutonic Order archive defines the roof covering as made of fired ceramic; the tower might have been covered with either copper plating with patina or painted shingles.

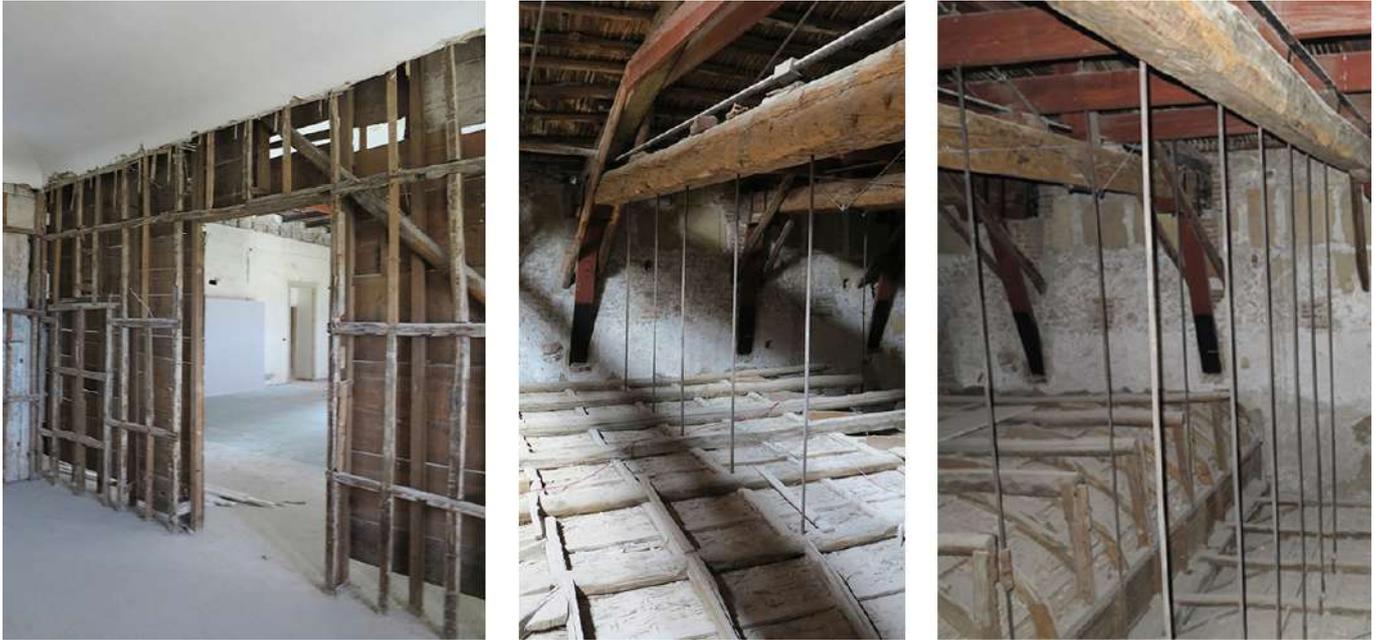
Fig. 4. On the left: timber partition made of two different frames, one covered by irregular pieces of timber boards and the other by woven reed mat. The transverse partition is a single timber frame covered by woven reed mat on the side of the room and by timber boards on the external side. In the middle: a larger vaulted ceiling over the timber partition. On the right: connection of a couple of ceilings over the two frames of the partition.

One couple of partitions consists of timber frames. One of the two lightweight walls is particularly interesting since it is made of two parallel frames (Fig. 4). The first one is composed of rough timber studs, connected to the top plate and to intermediate laths by cross halving joints reinforced with iron nails; a layer of woven reed mat supports the plaster. The second frame seems more recent: squared timber studs, joined by a top plate, are sporadically linked to the first frame by means of thin wooden connectors; irregular pieces of timber boards served as a base for the finishing. The cavity between the adjacent frames is occupied by two diagonal braces (Figure 4, left). The two frames are different in height, and their top plates support vaulted timber ceilings, which are sensibly different in shape and construction. Both vaults are hanged at wrought iron tie rods connected to the trusses. In the larger ceiling, the mid section of the ribs are borne by a group of aligned iron bars, which pierce the same tie-beam and are blocked against its extrados (Figure 4, middle); a second group of iron tie rods supports the basis of the vault, which is the top plate of the second timber frame, and are suspended from joists laid on consecutive tie-beams (Figure 4, right). The same joists support a secondary timber joist, pierced by tie rods bearing the ribs of the smaller vaulted ceiling. Upper heads of iron ties are threaded and fixed to timber elements by means of nut and washer.

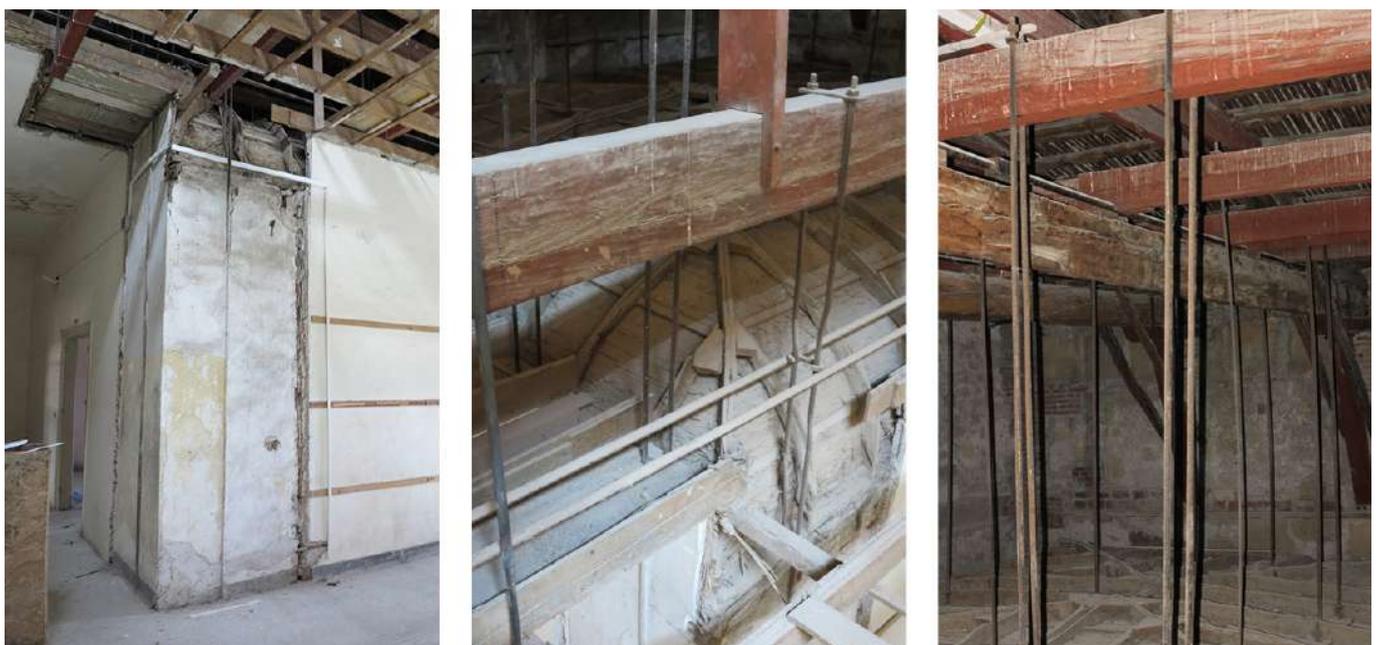
Fig. 5. Thin-tile brick partitions and corresponding timber vaulted ceiling. Some iron tie rods are visible on the surface of the lightweight wall.

As expected in the local historic architecture [8], the shape and stiffness of this ceiling are assured by extradors ribs (Figs. 5 and 6): in order to respect the curved shape of the ceiling, each rib is made of two layers of small pieces of timber boards, nailed one to the other.

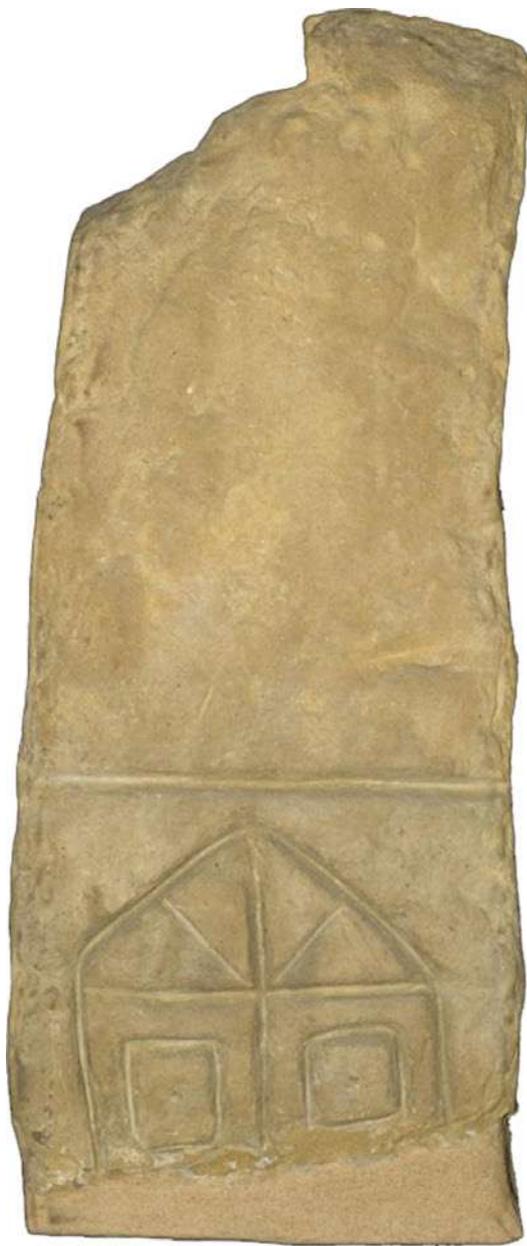
Fig. 2. Stele found in the necropolis of San Vitale, Bologna (Inv.: 11683, Archaeological Museum of Bologna).

The Etruscan marker of an inhumation tomb, found in the necropolis of San Vitale near Bologna and dating back to the end of the 8th century BC, is slightly later [5, 9]. A hut is engraved on this stele, whose roof structure is characterized by a configuration similar to that depicted in the front of Megaron 2. The central post of the hut continues until it intercepts the ridge of the roof, assuming the static role of a king post. As in the Anatolian drawing, the two rafters benefit from two struts which, with the same role as the queen-posts of Gordion, constitute further supports for the rafters, limiting their displacements.

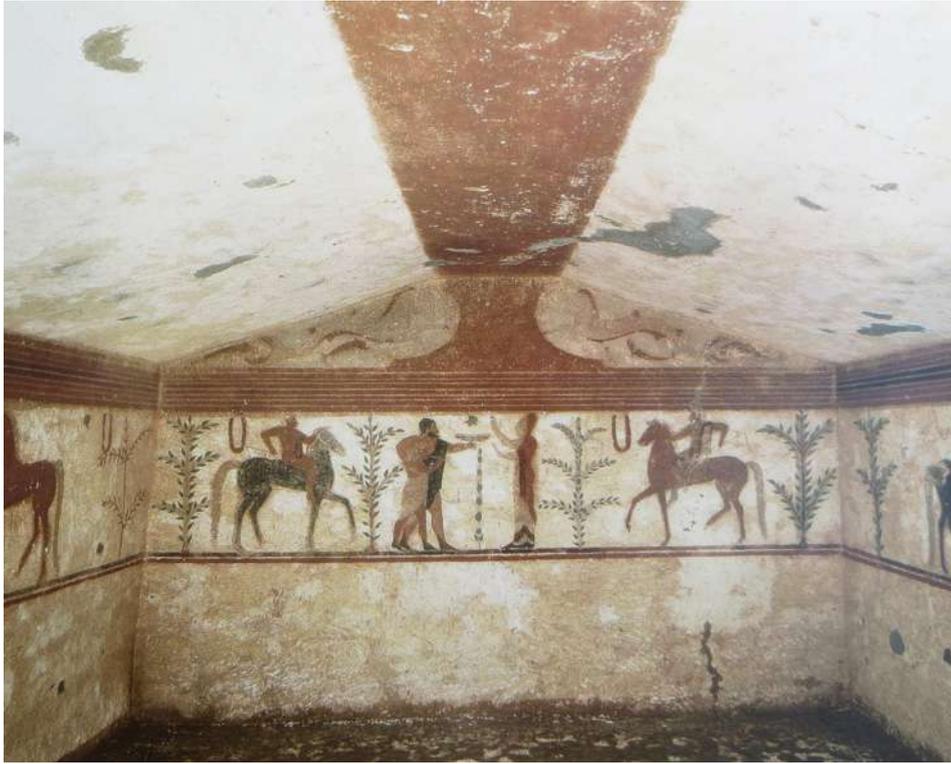
Fig. 5. Burial chamber of the tomb of Barone Kestner in the necropolis of Monterozzi, Tarquinia (VT).

In fact, in these examples, the support of the ridge beam assumes the characteristic hourglass shape in a time horizon that goes from at least the middle of the 6th century BC [20]. The enlargement of the section at the top evokes a corbel, helpful in connecting the *columen* to the vertical prop [9]. In the lower part, this shaping probably refers to a useful geometry to guarantee the equilibrium of an element stressed by compressive-bending stresses. It is strictly rational from a static point of view that the enlargement of the base depicts two triangular cleats or, more generally, inclined elements placed lat-

erally to the prop to counteract the rotation in the plane of the structural unit. In addition, the constraint at the base stiffened by the presence of the cleats reduces the effective length.

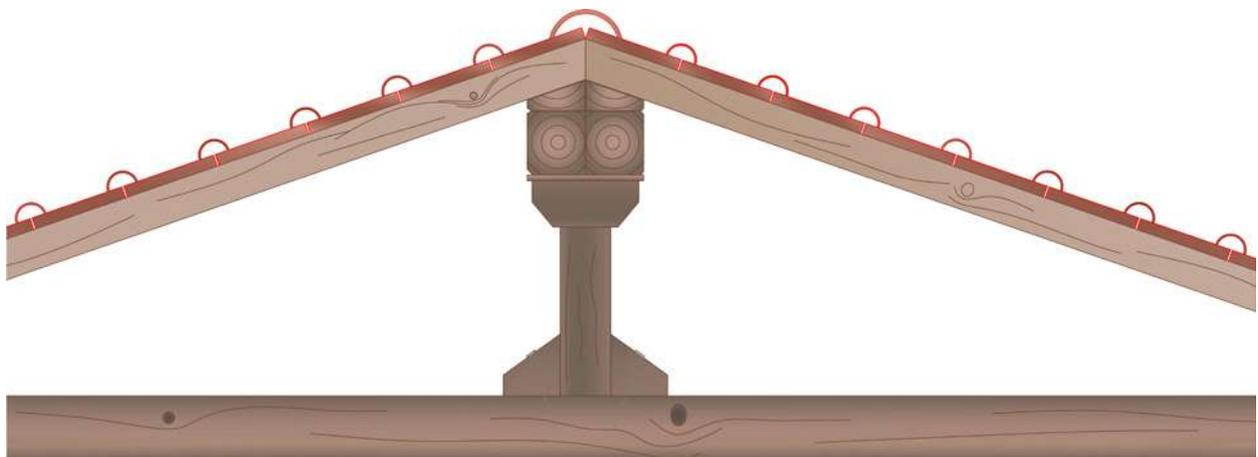
Fig. 6. Reconstruction hypothesis of the carpentry depicted in the Etruscan Orientalizing period tombs.

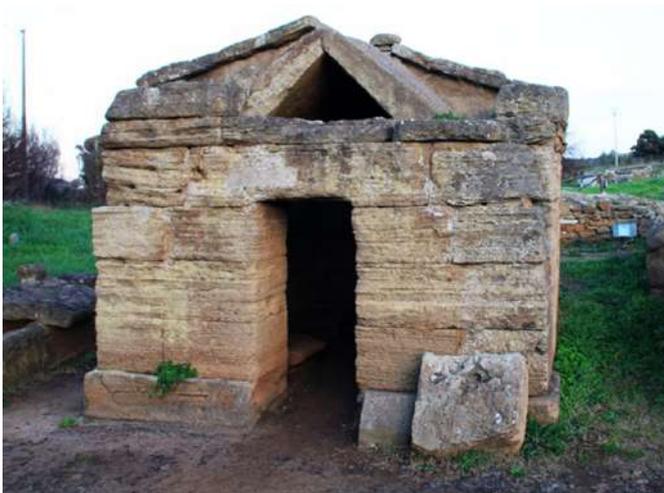
Fig. 8. Bronzetto dell'Offerente tomb in the necropolis of San Cerbone-Casone, Populonia (LI).

However, the thesis inspired by the configuration that characterizes the aedicule tomb of the Bronzetto dell'Offerente in the necropolis of San Cerbone in Populonia (6th century BC) remains valid: the continuation of the horizontal member sculpted beyond the joint could reproduce a beam, whose own weight, increased by the load deriving from the roof covering, guarantees equilibrium by counteracting the tendency of the common rafter to translate. The roofing carpentry in this example is composed of inclined lithic slabs but most likely paraphrases a wooden structure, which is contrasted to the foot by a sandstone (i.e., *panchina*) crowning beam.

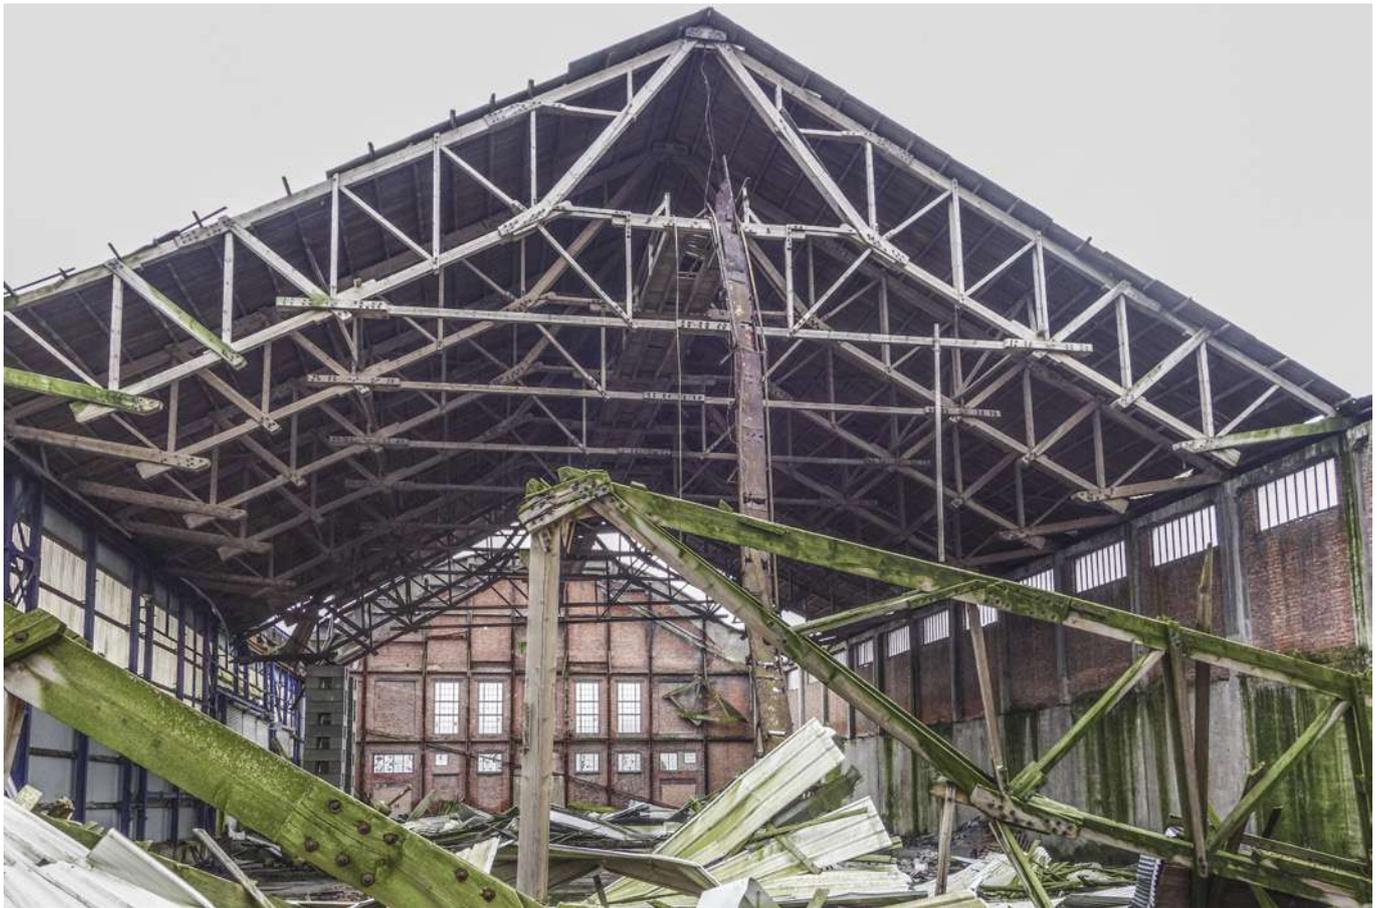
Fig. 7. The roof of a chemical factory in Willebroek (1926) built with the German system Kübler. The collapse started in 2013, and the building was torn down in 2017. (Photo by the Author).

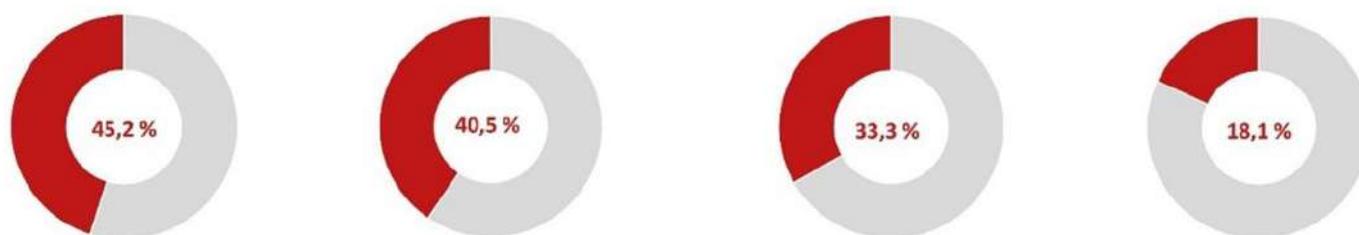
Fig. 3. Diagrams with the percentage of recovered material from the previous church for the roof's construction. From left (in red): recovery of arched ceilings, recovery of timber and slates for the roof, recovery of wooden floor frames and underlying ceiling, recovery of the lateral part coverage.

Most of the expected savings concerned the construction of the roofing system for the new building; in fact, the subsequent recovery percentage values were envisaged: arched ceilings: 45.2%; timber and slates for reinforcement and roof covering: 40.5%; wooden floor frames

and underlying ceiling: 33.3%; roofing with slates on the recess of the sidewalls, external part: 18.1%. In addition, a saving of one-third of the total cost of the windows was expected, but without specifying the number and type of reusable artifacts from the previous church.

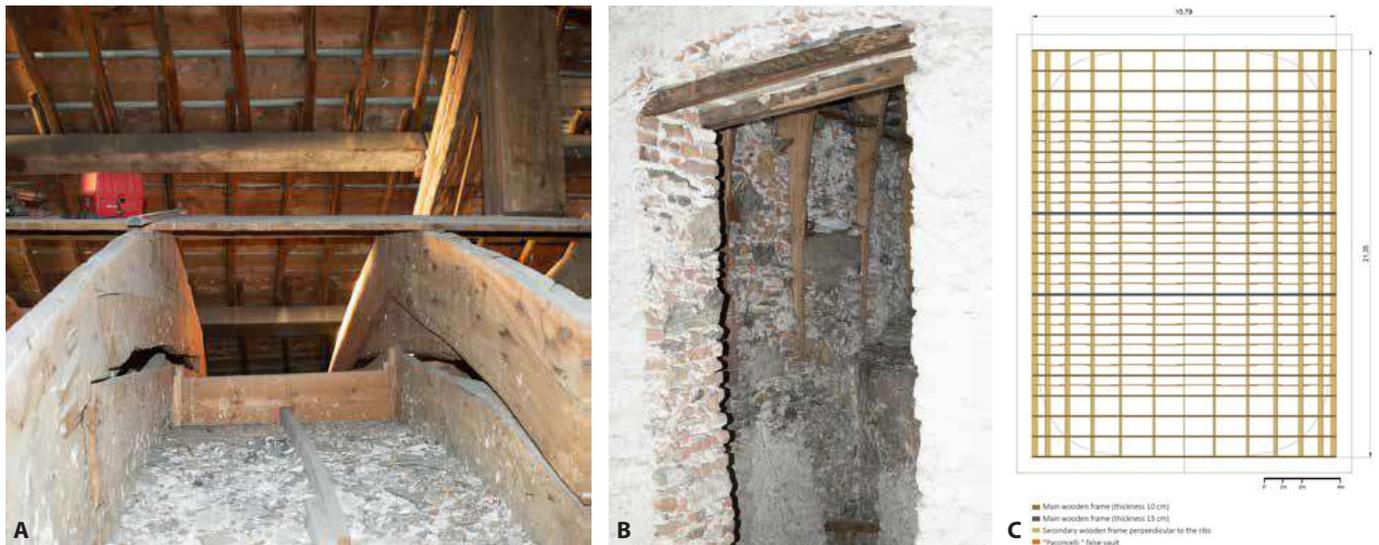
Fig. 4. A - Detail of the curved profile roof now devoid of the roofing mantle and protected by the gable roof. In the foreground, the reed vault of the inverted keel vault can be seen. B - Detail of the lower part of the ribs of the curved roof. C - Diagram of the curved roof structure (Image source: Accomasso 2019).

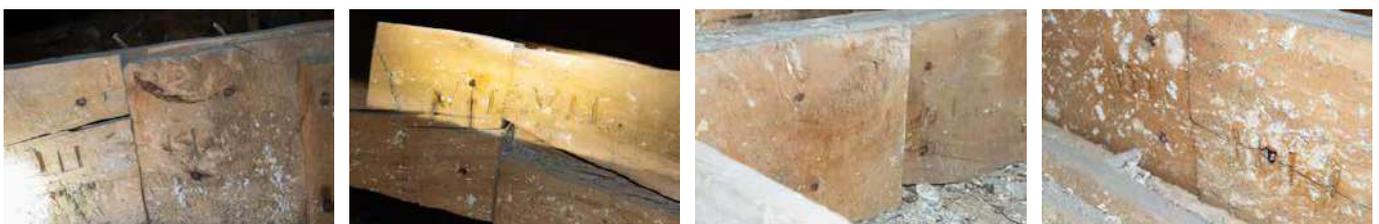
Fig. 5. Details of some wooden ribs engraved with Roman numerals.

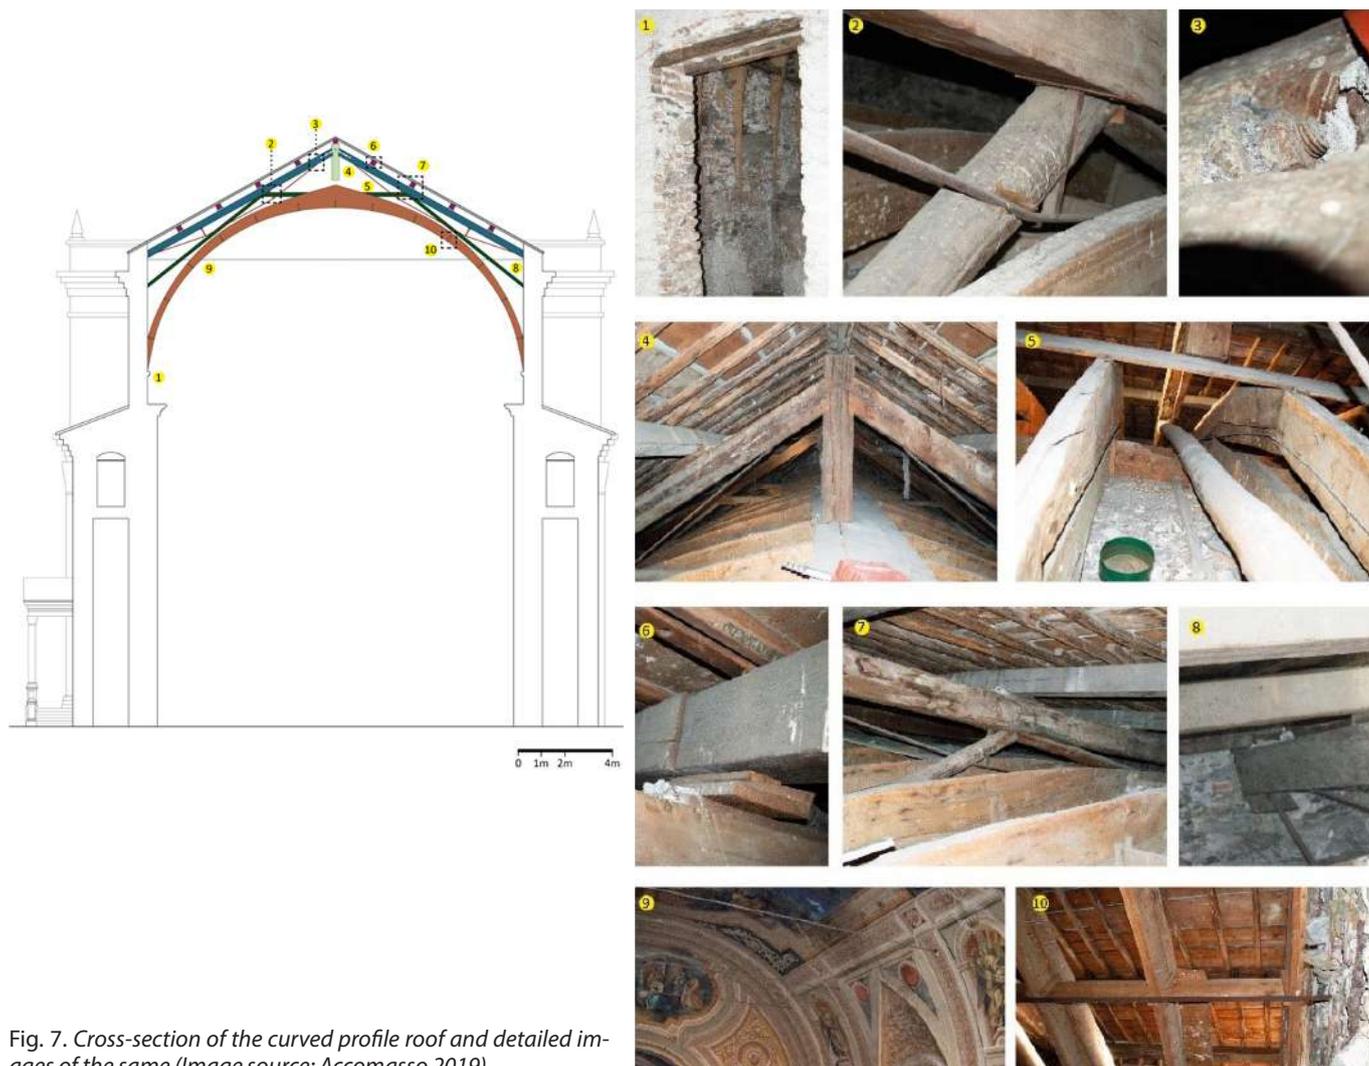
Fig. 7. Cross-section of the curved profile roof and detailed images of the same (Image source: Accomasso 2019).

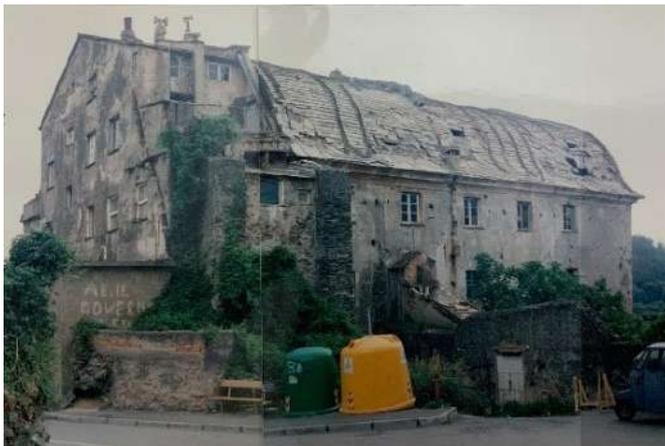
Fig. 8. Former spinning mill in Arenzano.

In Liguria, other cases of wooden vaulted roofs have elements in common with that of the church of Cogoleto. In particular, two of them appear to be in a geographical area adjacent to Cogoleto and are chronologically contemporary with each other and the 19th century Cogoleto's structure. The first is the former spinning mill of Arenzano [16] (Fig. 8). The main frame of the roofing system consists of ribs with a partly curved and partly straight profile. Commonly its shape could be considered an inverted keel, although there are some differences with this typology. In analogy to the church of Cogoleto, the resistant section of the elements corresponding to the warps is obtained by joining wooden boards and not by curved woods: the fibers of the wood of the curved rib portion are not parallel to the shape of the board. Adopt-

ing this form could be motivated by the intention to decrease the entity of the horizontal thrusts by unloading most of the load vertically to the walls.

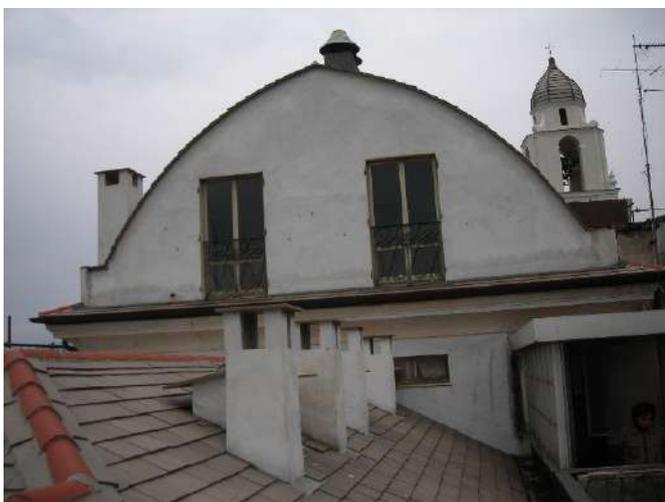
Fig. 9. Former Martinez Hospital.

The second building is the former Martinez Hospital in Pegli (Fig. 9), the roofing system of which, in 2006-07, was the subject of an in-depth diagnostic investigation [17]. The wooden frame of the roof is made up of a series of curved beams made up of several elements, in the longitudinal and transversal directions, joined together using nails at an irregular pitch of about 95 cm. The elements making up the beams have an average thickness of 4 cm and a height of about 22-24 cm. The ribs made with a series of reduced dimensions boards nailed together represent an element of similarity with the vault of the Cogoleto's church. Instead, the two shapes of the roofs appear different: while the former hospital of Pegli tends to have a pointed arch, the Church of S. M. Maggiore is more similar to a round arch. At this point, the question may arise whether there is a connection between these similarly shaped structures and whether, in some way, we can speak of reciprocal influences. For the moment, this part of the research is in progress as, at present, there are still several elements that cannot be given a precise chronological location.

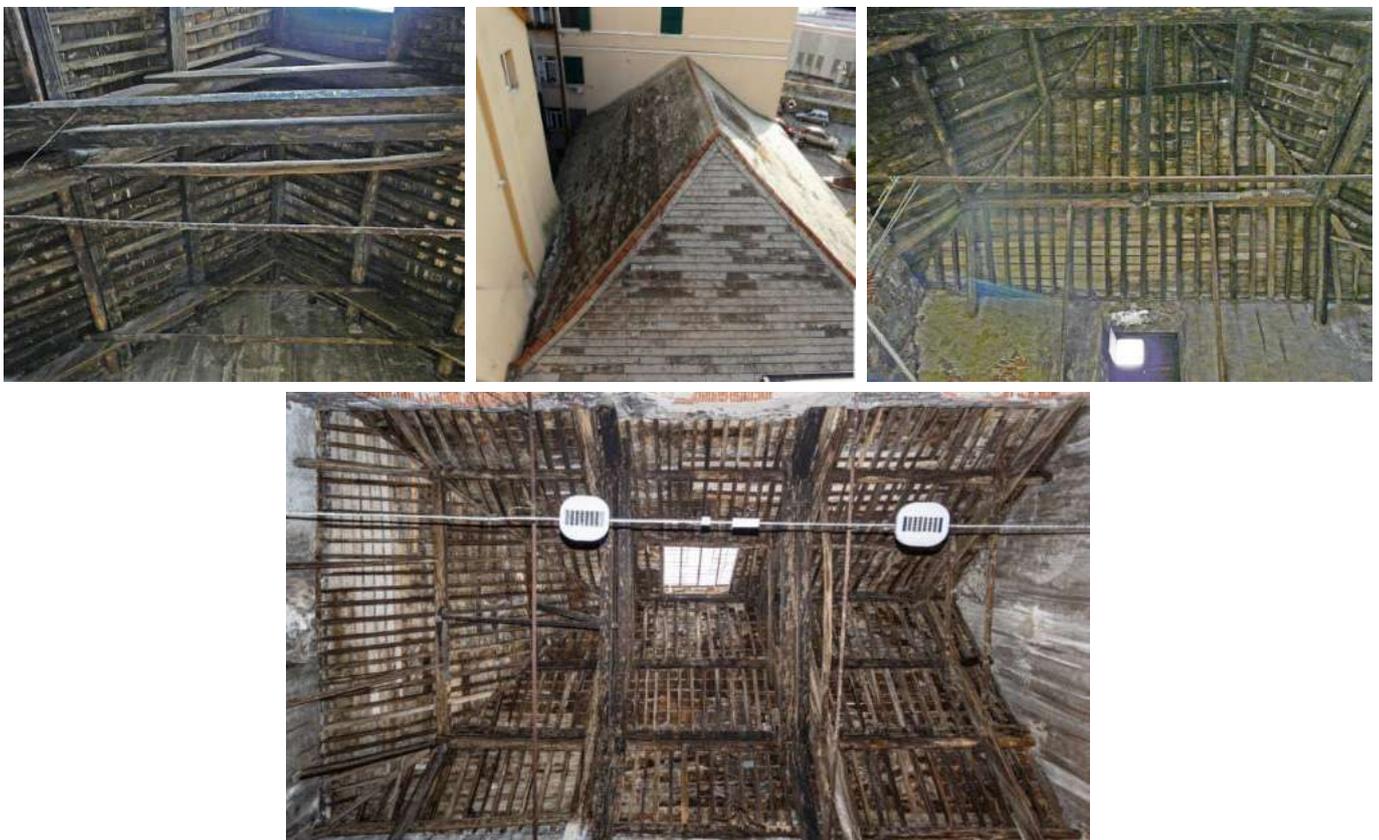
Fig. 2. The ancient roof of the salt warehouse in the Molo district (Genoa).

The pseudo-trusses in the salt warehouse in vico Malatti are positioned at about $1/3$ and $2/3$ and $3/3$ of the longitudinal axis of the structure, in turn, reinforced,

headed into the masonry below the level of the wall timber plates, and from the southern transverse perimeter wall, in which all the purlins have their heads stuck, except the two of the north pitch. In our case, integrating other elements, such as the pseudo-trusses, makes our structure unusual because there are very few similar cases in Genoese architecture, which will be analyzed later. On the west and north perimeter walls, the circular section “wall timber plates” can sometimes be clamped on top of the masonry. Regarding the perimeter wall to the east, three distinct circular wooden elements are clearly visible, which act as “wall timber plates” when connected to the masonry or the truss and as tertiary beams where they are not supported. They are slightly offset from each other, and the two at the end have one head embedded in the transverse masonry and the other resting in correspondence with the interlocking of the rafters of the two central trusses, but at a slightly higher level. The roof is made up of two orders of purlins on all three sides, and the ridge; all these elements are supported both by their interlocking with the masonry and by the rafters and tie beams of the “pseudo-truss” to which they are connect-

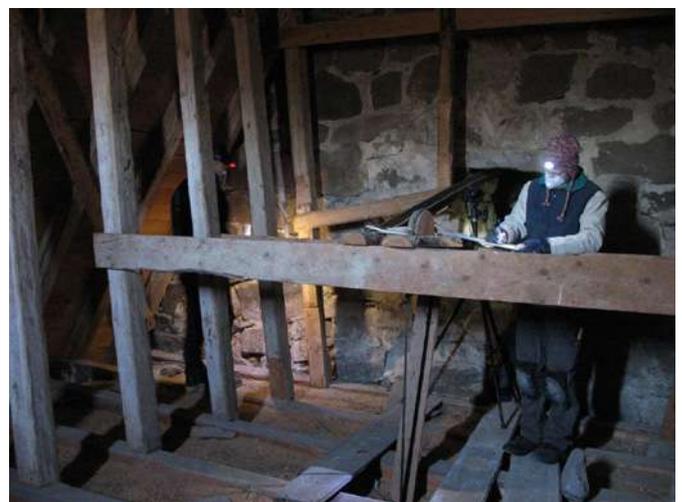
Fig. 2. Survey of trusses in the chancel of Knätte, Västergötland, Sweden. (Photo by the Author).

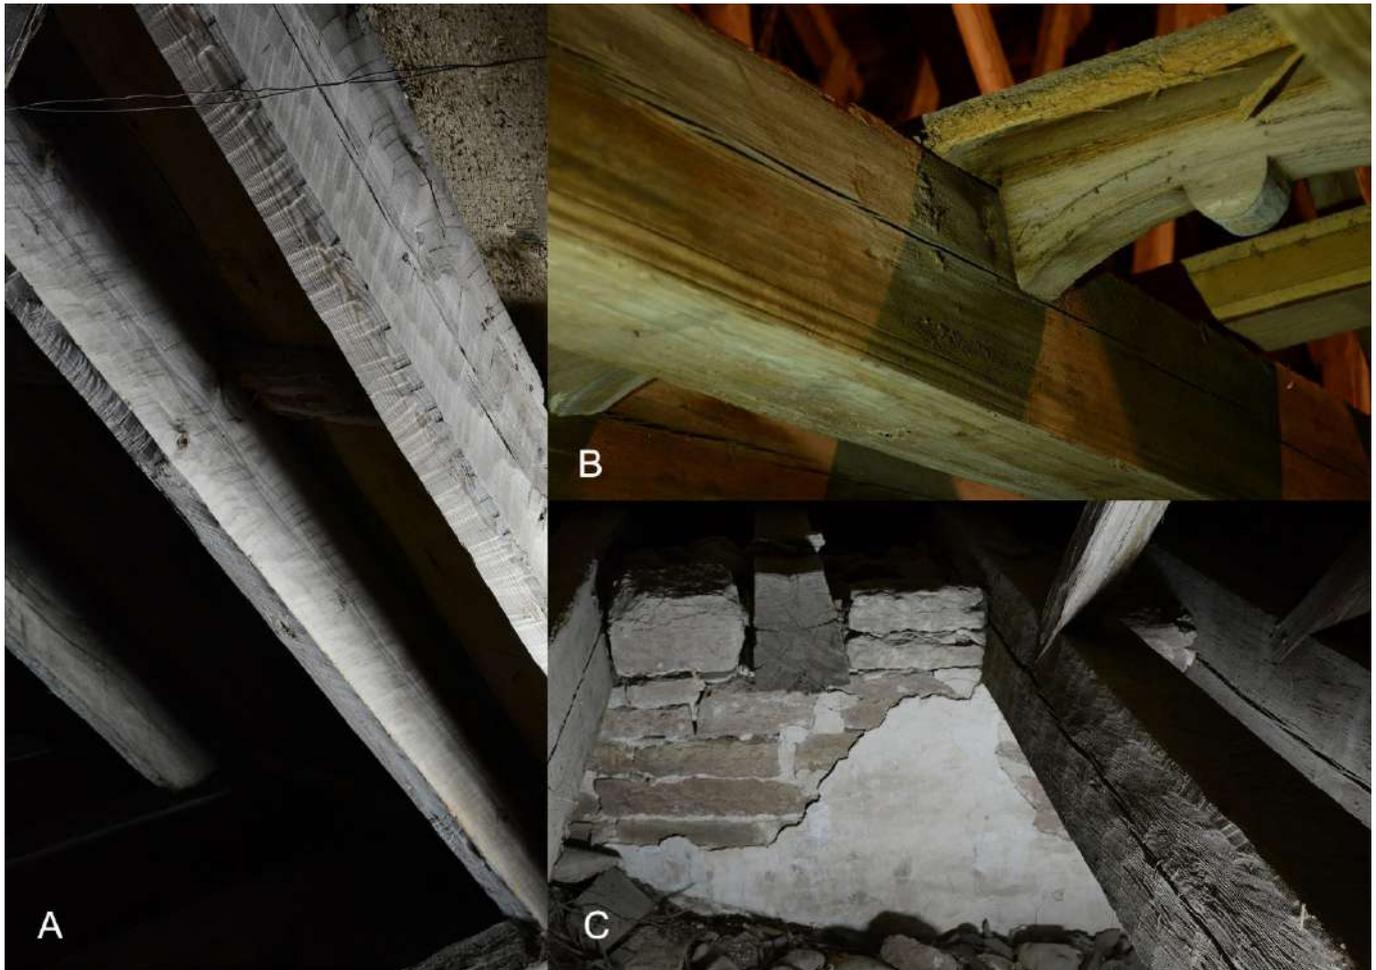
Fig. 7. Different 12th century surface treatments. A. Slender rafters in Jäla church, Västergötland, 1124-1142 d, of cleaved pine and oak, hewn with a felling axe in the direction of the fibers, the Scandinavian technique of "sprätthuggning". B. Tiebeams and ornate steering plate in the nave of Hagebyhöga church, Östergötland, 1119/20 d; the surfaces worked with a plane, and the edges enhanced with a profile plane; note the traces of a later inserted ceiling on the bottom of the beam. C. Tiebeams in the nave of Mularp church, Västergötland, 12th century, the beams are full timbers hewn to a conical shape in the technique of "sprätthuggning", the sides finally flattened with a broad axe working cross the fibers, leaving a stroke of "sprätthuggning" along the edges. Note the flush and tight strut lap joint and the embedding of the beams in the masonry, originally plastered. (Photos by the Author).

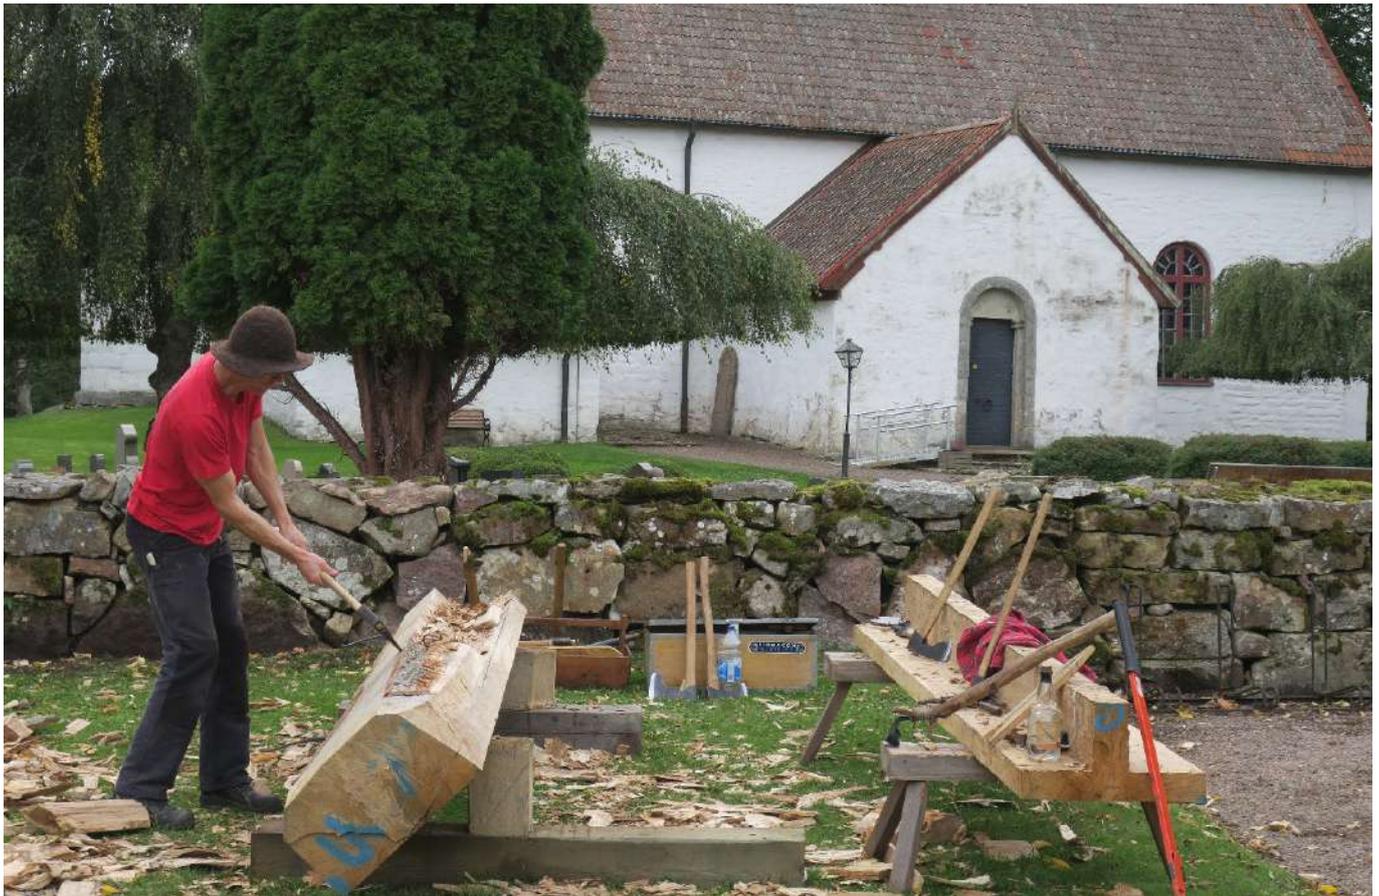
Fig. 9. Carpenter Mattias Hallgren hewing a new wall plate of oak to the church of Gökhem, Västergötland, Sweden, in 2019 using the same tools and techniques that could be read on the original. The church in the background still has 20th century roof tiles. (Photo by the Author).

A few high medieval timber structures have recently been the object of well-planned restorations and conservations. A good example is the works concerning the unique 1140s nave roof of Gökhem church, Västergötland, 2017-2021 (Figs. 9 and 10). Before a planned renewal of the 20th century roof covering of tiles, a study was made of the structure in the attic, which partly was covered in birds nests and waste material, making an evaluation of damages difficult. An archaeological cleaning of the attic was

made by the author and craft researcher Mattias Hallgren, followed by a buildings archaeological investigation and thorough inventory of damages, the latter showing severe inner damages of fungi in several tiebeams, aggravated by their embedment in the masonry [33].

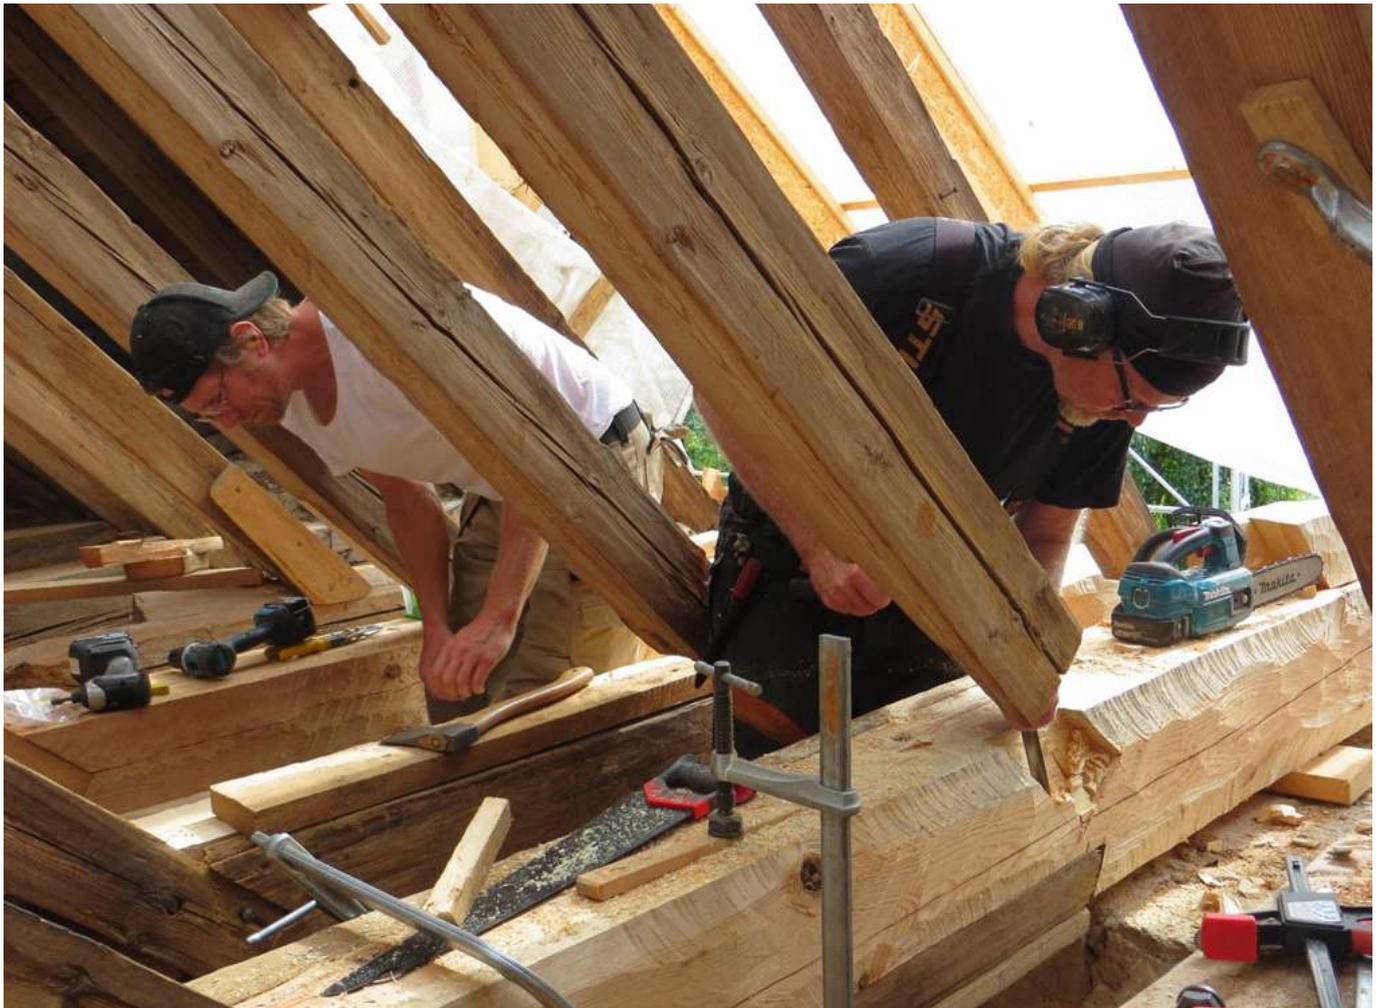
Fig. 10. Restoring severely damaged tiebeams (1140/41 d) in the nave roof of Gökhem church, 2019. Carpenter Bengt Bygdén making a recess for a lap joint. Note the hewing of the tiebeams, made accordingly to the technique used on the scarfed piece. The log was cut square with a felling axe working in the direction of the wood fibers; finally, the somewhat protruding sides got flattened with a broad axe working across the fibers, a treatment connected to the original visibility of the beams in the church interior. (Photo by the Author).
