**Remarkable historic timber roofs. Knowledge and conservation practice.
PART 1 - Construction history and survey of historic timber roofs**

TEMA
Technologies
Engineering
Materials
Architecture

**Remarkable historic timber roofs. Knowledge and conservation practice
Part 1 - Construction history and survey of historic timber roofs**

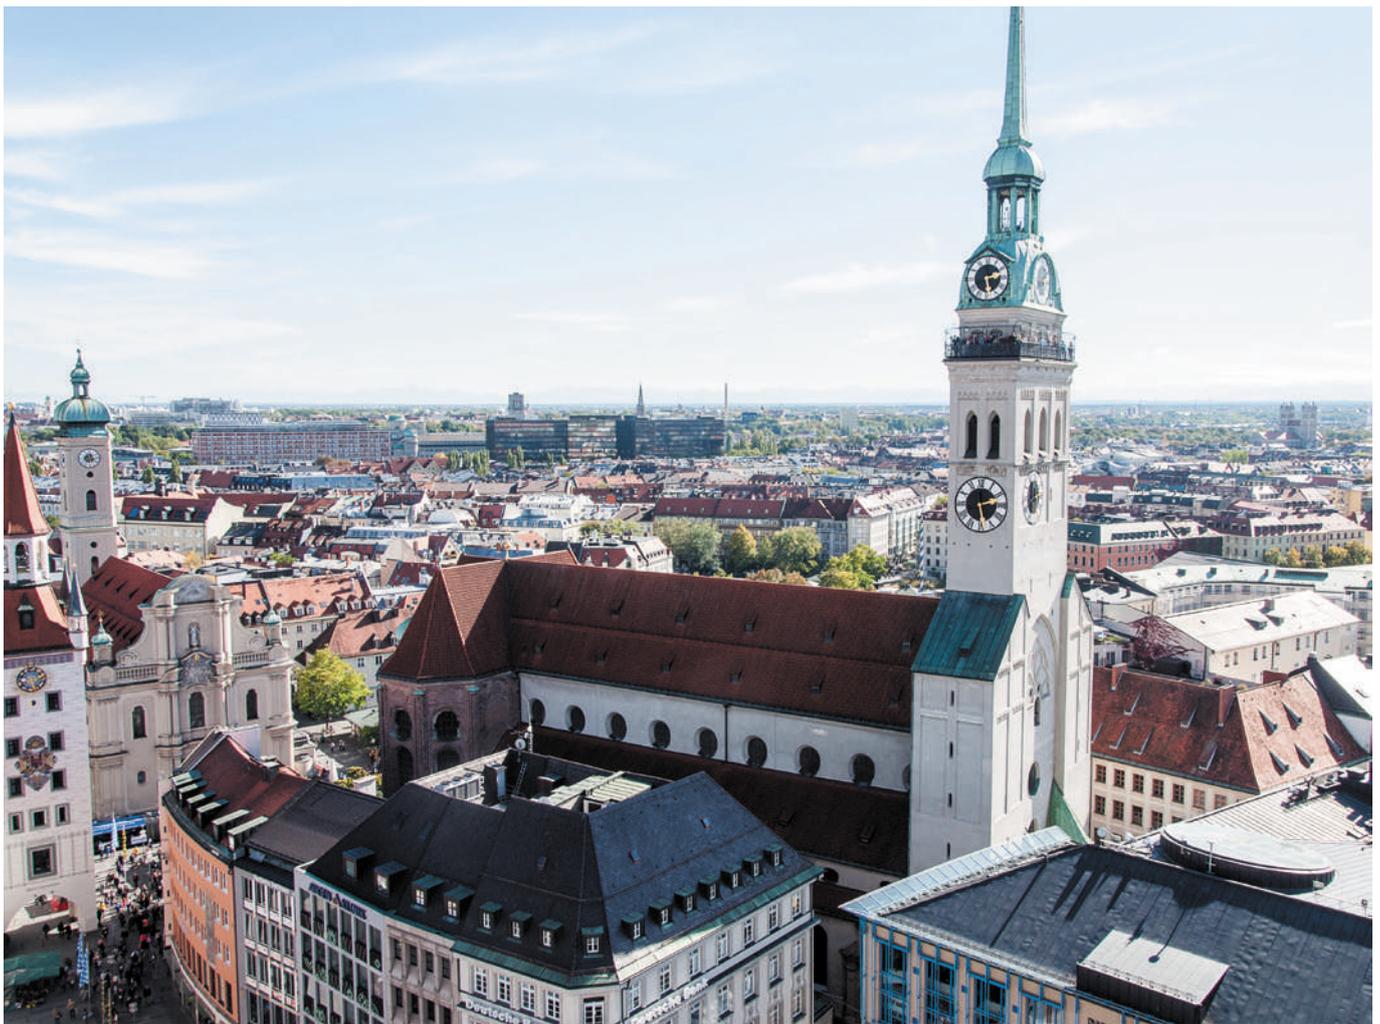
Fig. 2a. Church of St. Peter

The roof of the nave of the Basilica of St. Peter, built after 1327, consists of identical trusses stiffened by scissor braces. There is no longitudinal bracing except the roof

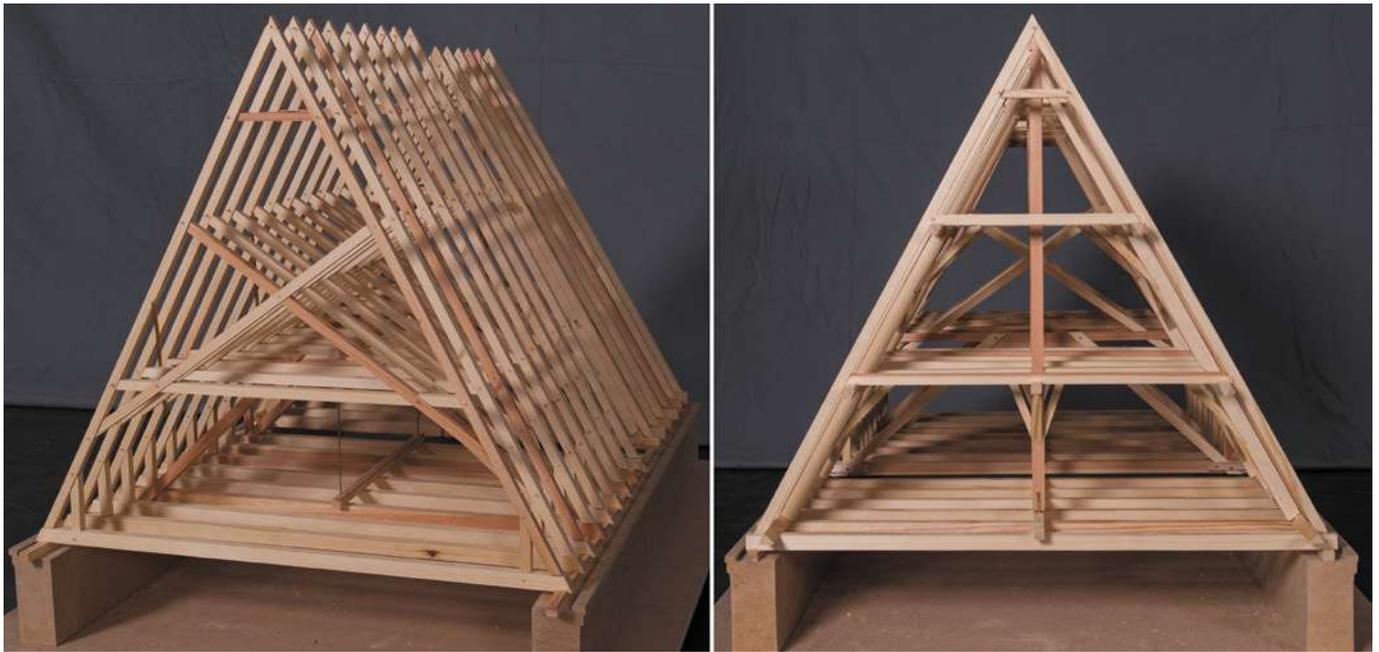
Fig. 2b. Roof constructions of St. Peter – the medieval roof of the nave (left) and early modern roof of the presbytery (right). (Model: C. Knobling, Picture: I. Mühlhaus).

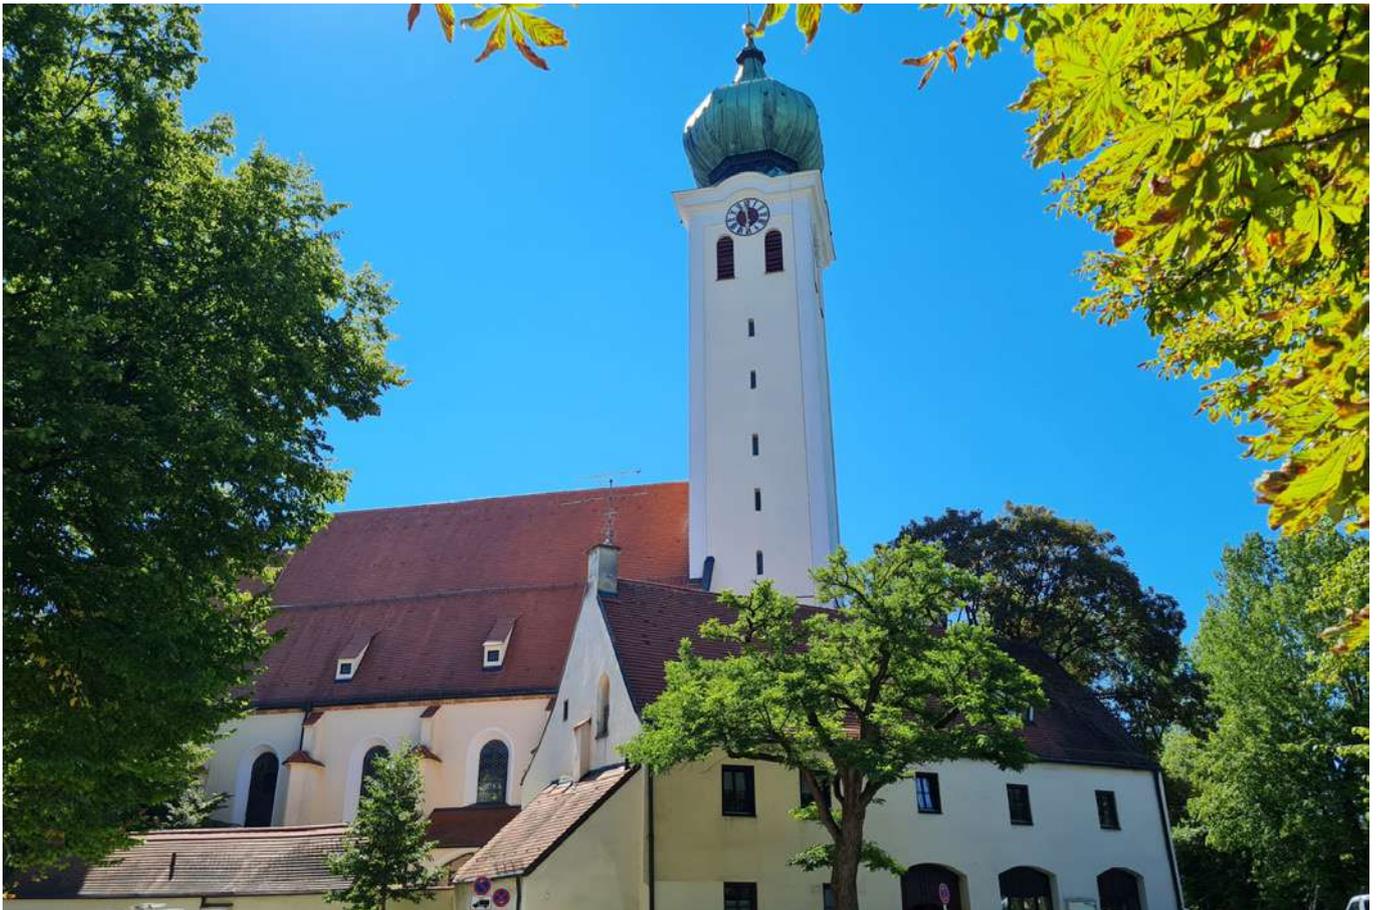
Fig. 3a. Pilgrimage church St. Mariae Himmelfahrt in Munich-Ramersdorf.

The roof of the pilgrimage church *Mariae Himmelfahrt* in Ramersdorf was built around 1360 [9]. A wooden vault was once integrated into the roof structure. It had the form of a half quatrefoil, i.e., it consisted of a central barrel vault and lateral half-barrel vaults. The vault was resting on longitudinal beams, two on consoles at the side walls and two fixed with tenons at the interrupted tie-beams of the roof. The interrupted tie-beams are supported by king posts. Bent ribs, made of interlocking pieces of wood, supported the cladding. They were fixed on the longitudinal beams with tenons. Scissor braces stiffened the trusses and transferred the tensile forces above the vault.

The construction of the vault was not based on Nordic models, where such forms were shaped primarily by the addition of short beams bevelling the lower angles [5] – the Ramersdorf vault was an independent structural unit

(but firmly connected to the roof). This refers more to the wooden vaults of the Veneto (e.g., San Zeno in Verona, see below) [10, 11]. As early as 1445, the timber vault was dismantled and replaced by the still-existing solid vault [12].

The reconstruction is based on the results of building archaeology. Traces of the lost vault were found on the still-existing roof and walls, e.g., mortices, former wooden joints or imprints of the planks of the vault in the mortar of the side walls and gable walls and on the beams of the roof. In this way, it was possible to find out not only the geometry but also the dimensions of the single components of the construction.

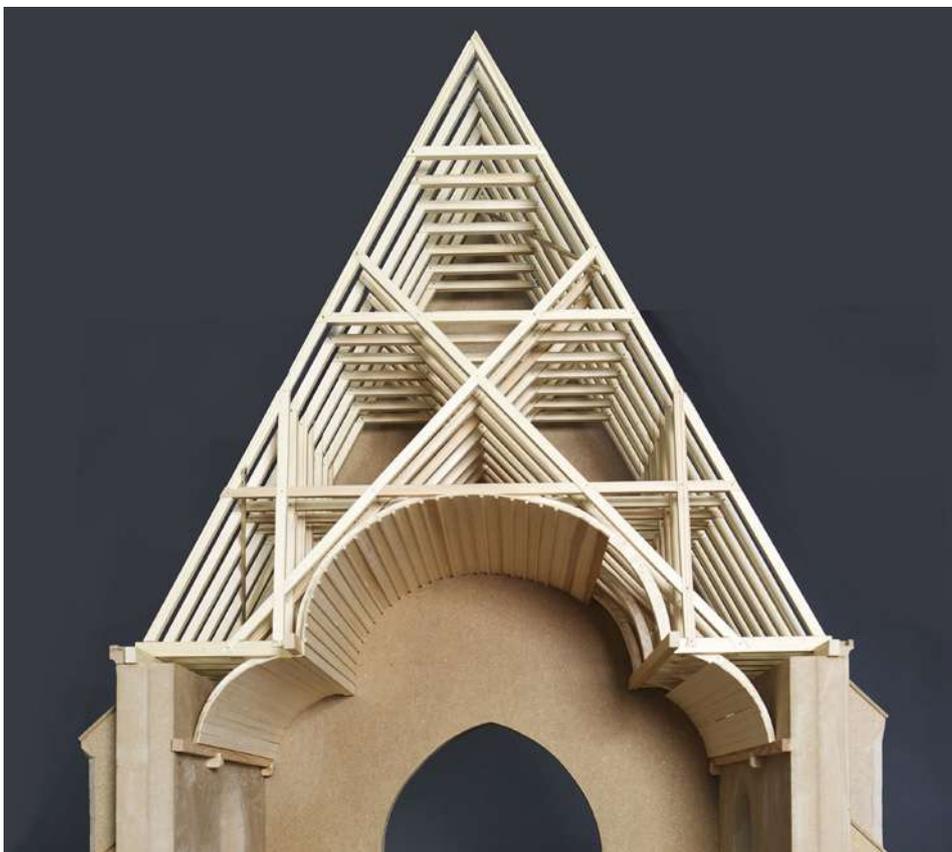
Fig. 3b. Roof and timber vault of St. Maria Ramersdorf. (Model: C. Knobling, Picture: I. Mühlhaus).

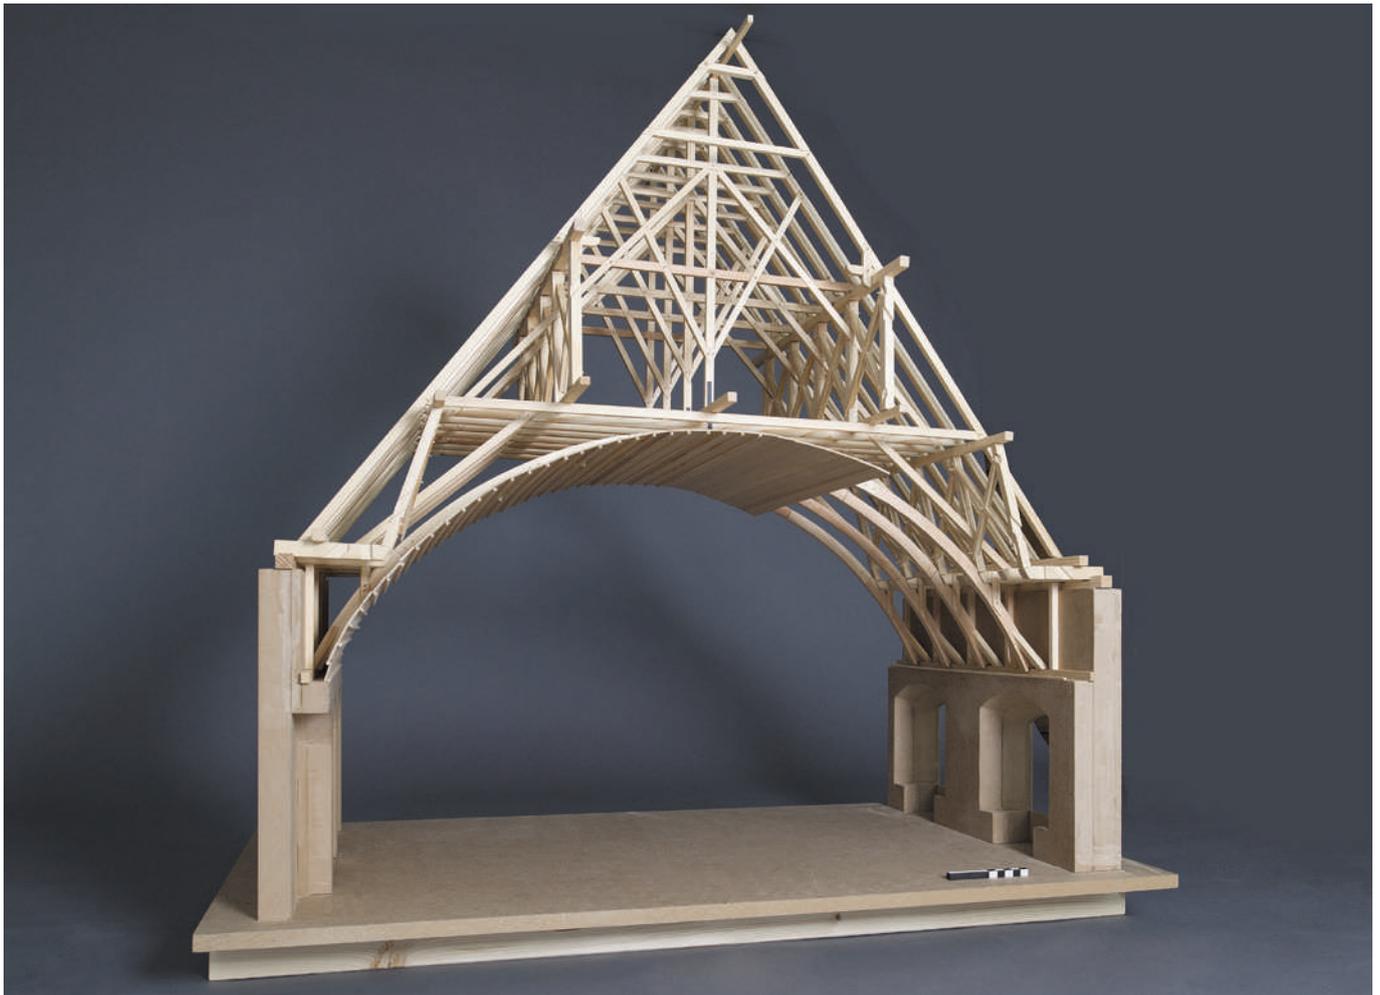
Fig. 4b. Roof and timber vault of the Altes Rathaus. (Model: C. Knobling, Picture: I. Mühlhaus).

large assembly hall of the town, spanning over 18.40 meters without supports. The roof construction contains a timber vault, which was supposed to be the prestigious ceiling for this most important room of the municipality. Since the view of the wooden vault was not to be disturbed, the construction also had to work without a continuous tie beam. The vault is made of wooden ribs, forming a segmental arch. It sets on below the eaves and extends to the lowest collar beam of the roof construction.

The structure above is formed like a conventional roof with struts, diagonal bracing, and king post. The lower part, which had to contain the vault, needed a specific solution: master builder Heinrich von Straubing [13] placed half-timbered walls alongside the vault, which had to stand inclined due to the limited space. The vault was connected to the roof structure with short beams and punctually supported by the king post.

The construction survived for more than 400 years. Unfortunately, the roof was destroyed in 1944 before it could be repaired. The reconstruction model still illustrates the builder's eagerness to experiment, which led to such an unconventional and unique construction.

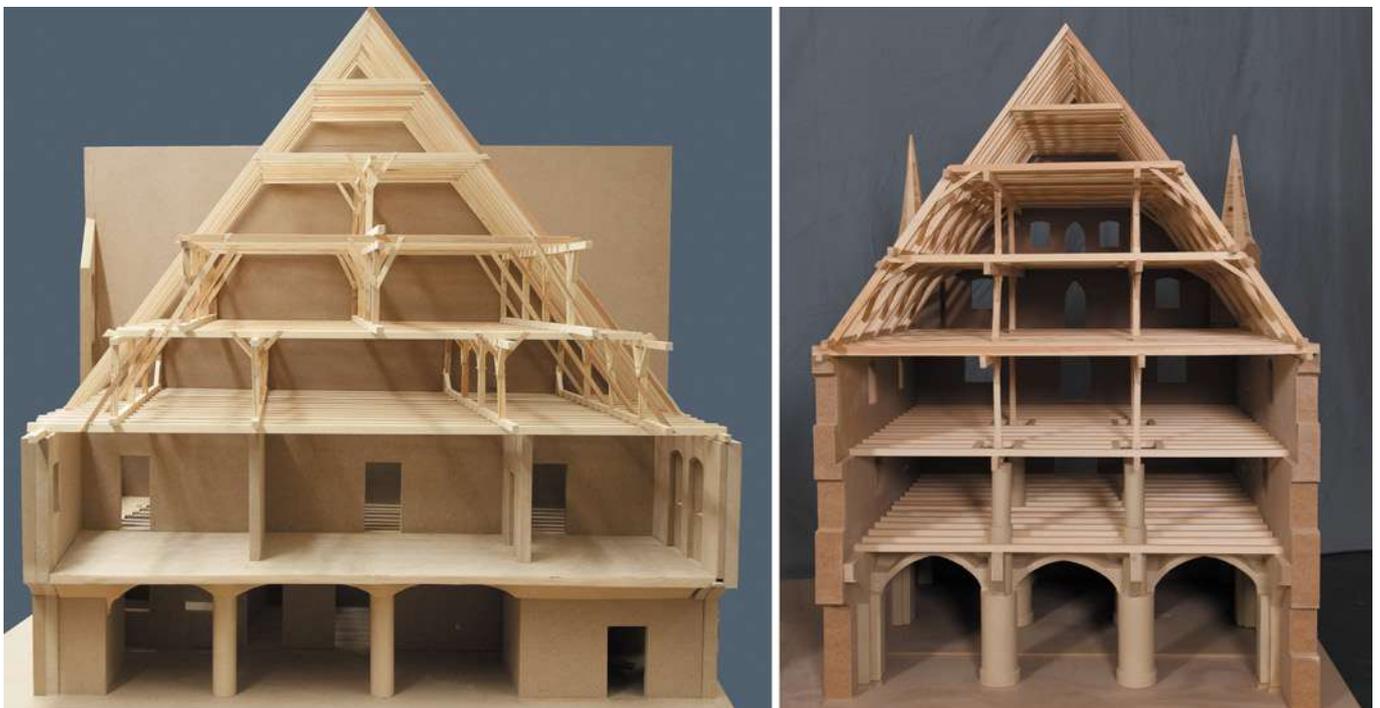
Fig. 5b. Municipal stables (left) and armory (right). (Model: C. Knobling, Picture: I. Mühlhaus).

century (Stables) and 1491-93 (Armory) [6]. They are good examples of prestigious buildings of late medieval citizenship. The constructions had large base widths (Stables: 20.30 m; Armoury: 16.30 m). Since the roofs could be supported by intermediate walls, the spans were nevertheless small. Both the stables and the armoury used a combination of vertical struts (*stehender Stuhl*) and raking struts (*liegender Stuhl*), which is common for roofs of this period and size. The elaborate construction of both roof structures indicates that the attics were used as storage floors and were, accordingly, heavily loaded.

The reconstruction is based on archival sources from plans from the 18th century, which could be found in the collection of the City Museum. Further sources like schematic drawings and historic photographs could be found in the municipal archive of Munich.

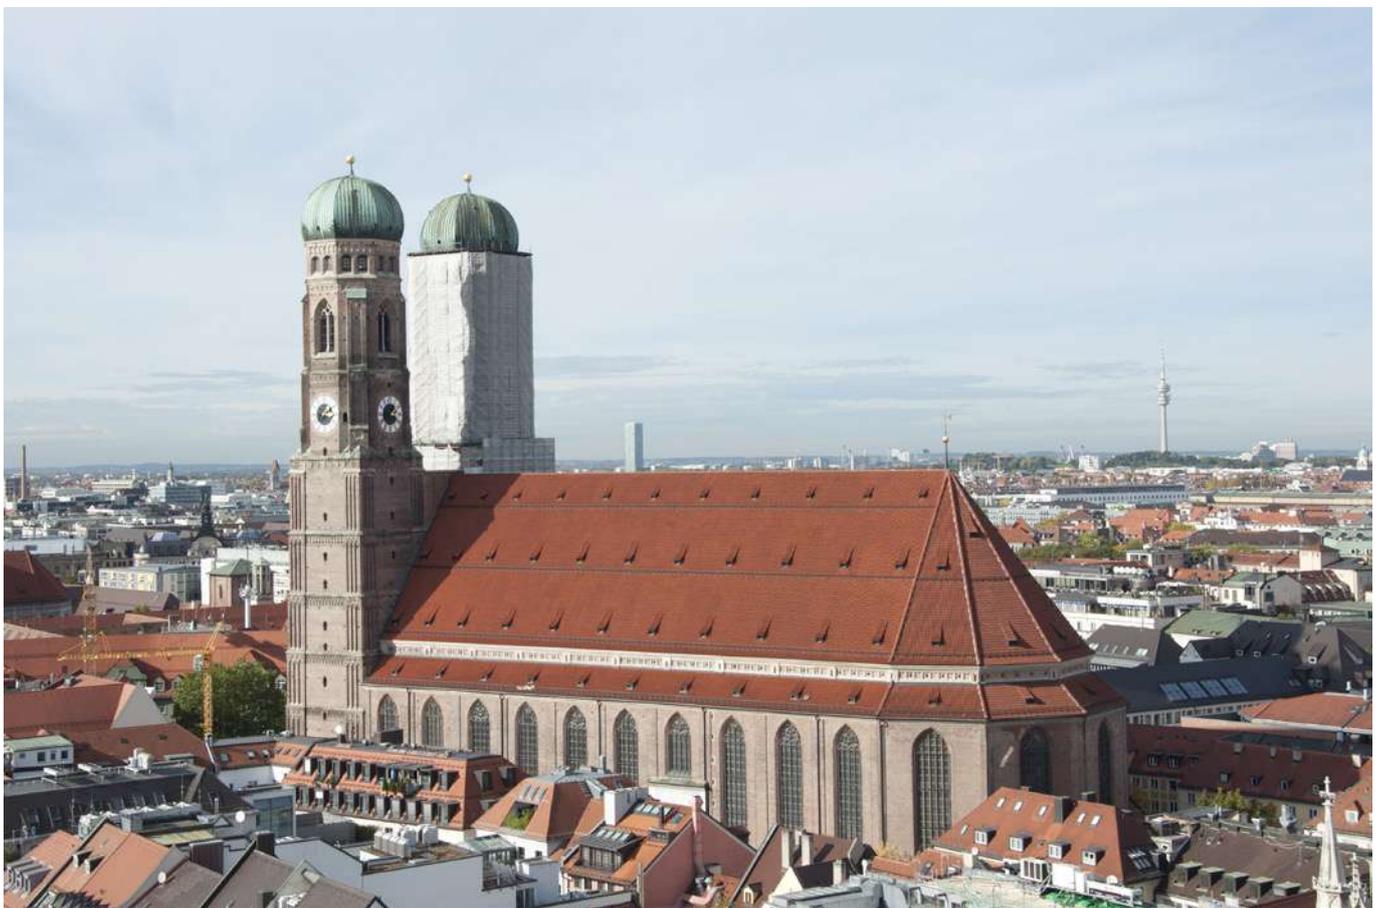
Fig. 6a. *Frauenkirche*, roof and tower roofs ("Welsche Hauben").

The high *stehender Stuhl* in the middle allowed the huge dimensions to be handled. It was both a rigid core and an aid for the erection of the roof structure. Similar constructions can be found, among others, in Wasserburg, *St. Jakob* (1417), in Laufen an der Salzach, *Stiftskirche* (1436), in Amberg, *St. Martin* (before 1442), in Wasserburg, *St. Jakob* (1417) and Landshut in the churches of *St. Martin* (after 1475) and *St. Nikola* (1481). Especially the similarity to the roof of *St. Martin* in Landshut indicates a close relation between the builders [13].

The reconstruction of the roof of the *Frauenkirche* is mainly based on sketches from students from the 1930s from the archive of the *Architekturmuseum* of the Technical University of Munich and drawings and photographs of the ruined roof from the archive of the diocese and the archive of the Bavarian state office for heritage conservation. The roof was also published in the books of Gottgetreu [24] and Ostendorf [10], albeit with minor inaccuracies.

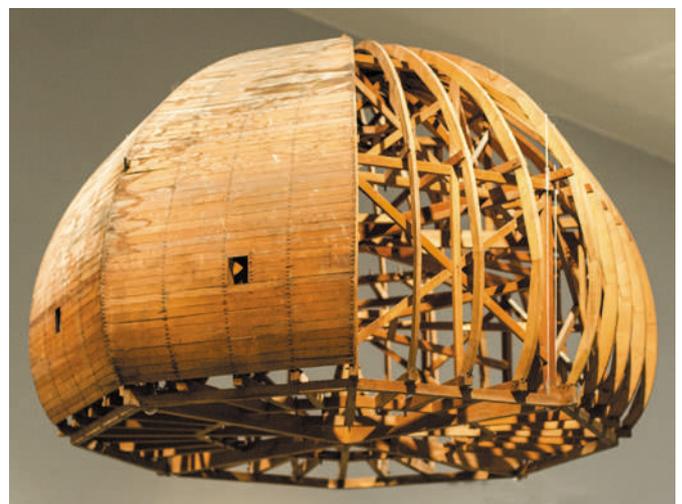
Fig. 7. Model of the helmed roof (*Welsche Hauben*) of the towers of the Frauenkirche. (Model: Architekturmuseum TUM, Picture: I. Mühlhaus).

The sources for the reconstruction were sketches by students from the 1930s from the archive of the *Architekturmuseum* of the Technical University of Munich

and historical photographs from the archive of the Branekämper company, which rebuilt the destroyed Frauenkirche after the war. There are also two models of the construction, one in the *Architekturmuseum* of the Technical University of Munich and one in the *Deutsches Museum*. Today's *Welsche Hauben* are thin concrete shells.

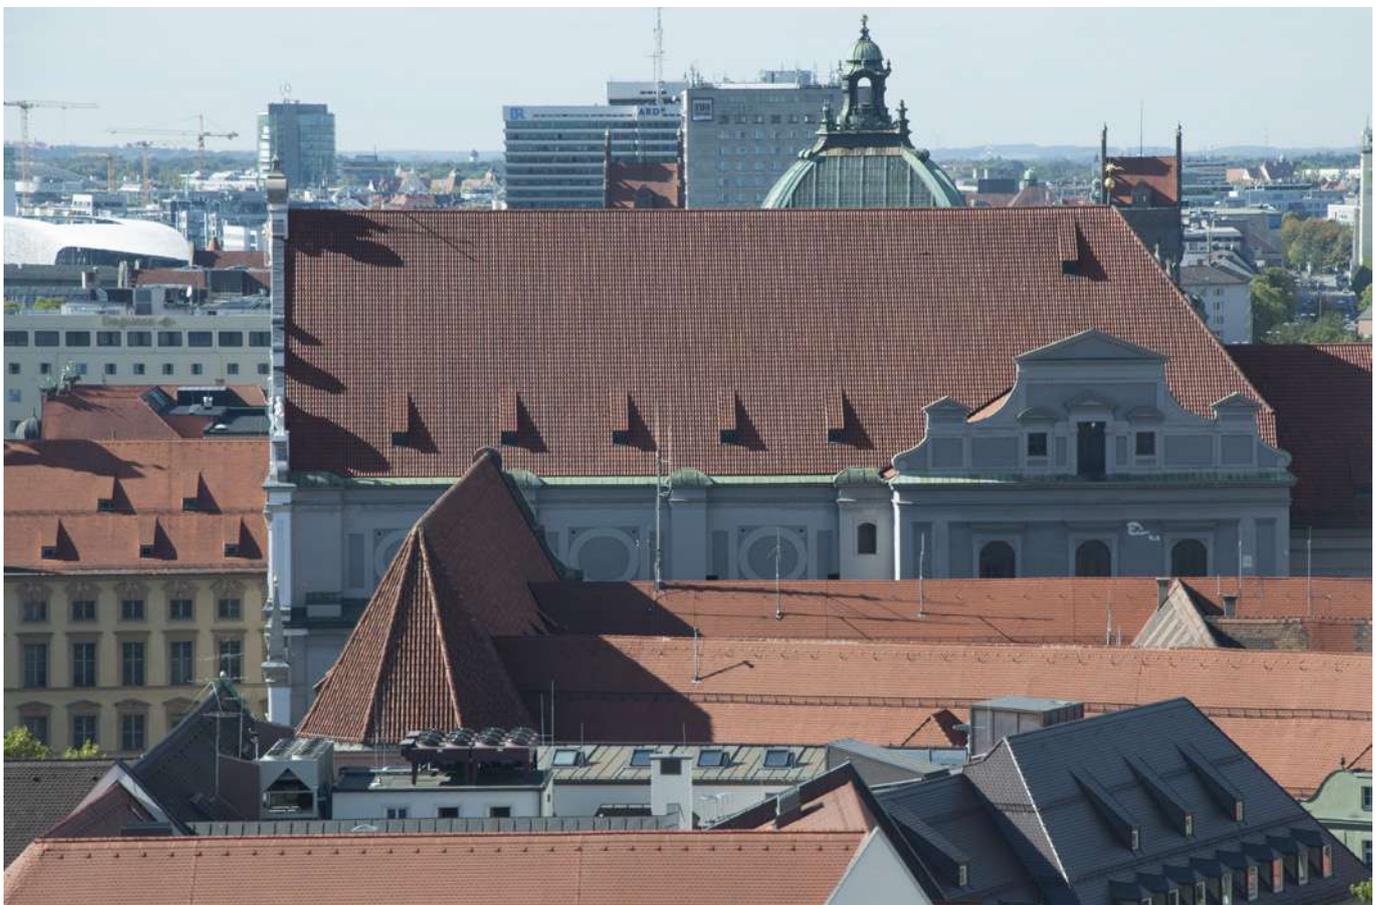
Fig. 8a. Jesuit Church of St. Michael (Michaelskirche).

A special feature was the “vault stamps” – beams lying on the vault and connected to the roof structure by v-shaped struts. These were intended to counteract deformations of the barrel vault by means of the load of the roof [15]. This kind of construction is also used in other Jesuit churches (e.g., in Landshut).

The reconstruction is based on sketches by students from the 1930s from the archive of the *Architekturmuseum* of the Technical University of Munich and historical photographs from the archive of the Bavarian State Office for the Preservation of Monuments. A model of the construction is preserved in the *Deutsches Museum*, but its details are inaccurate.

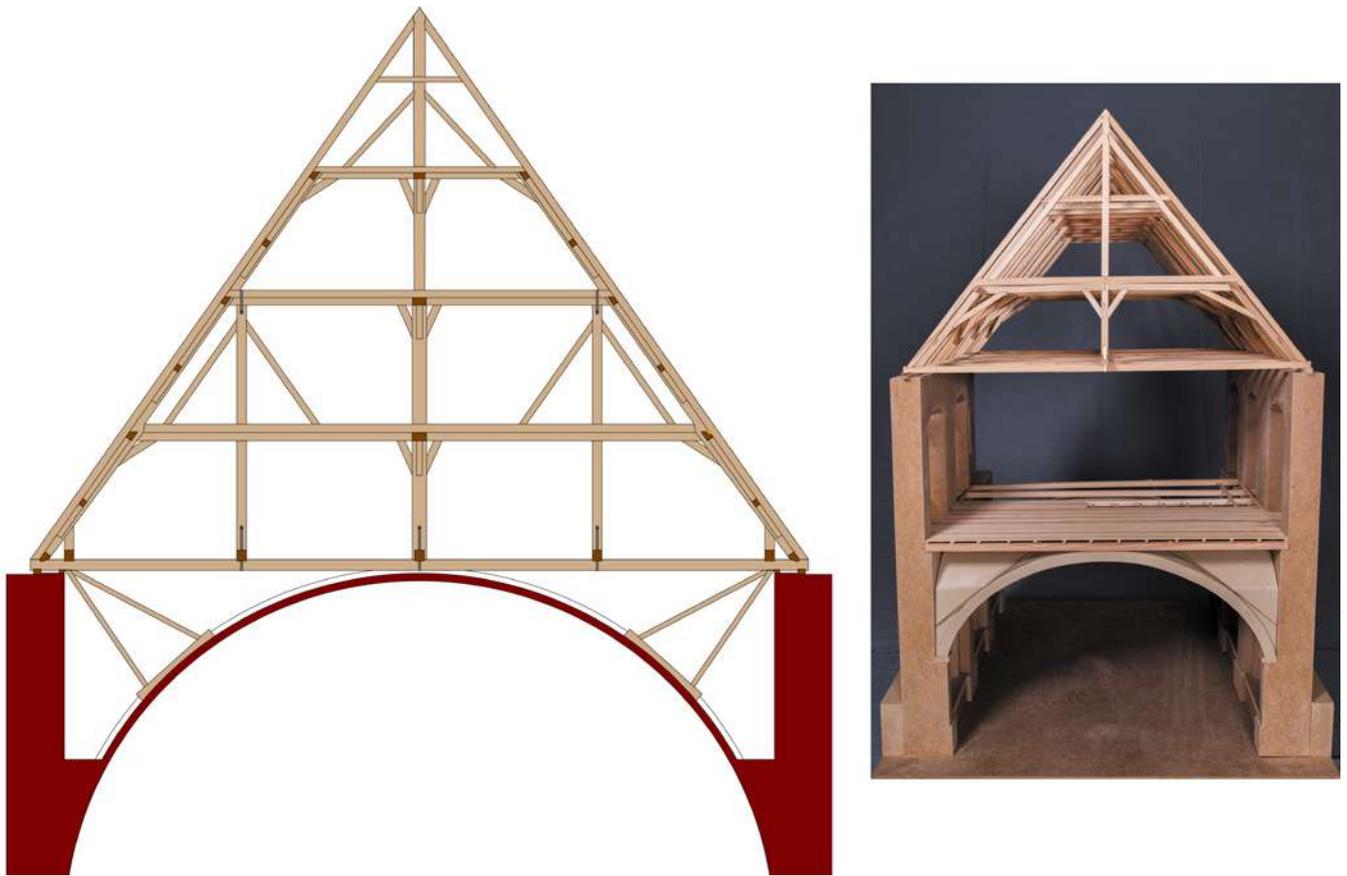
Fig. 8b. Roof construction of the Michaelskirche (left) and of the Antiquarium (right). (Model and drawing: C. Knobling, Picture: I. Mühlhaus).

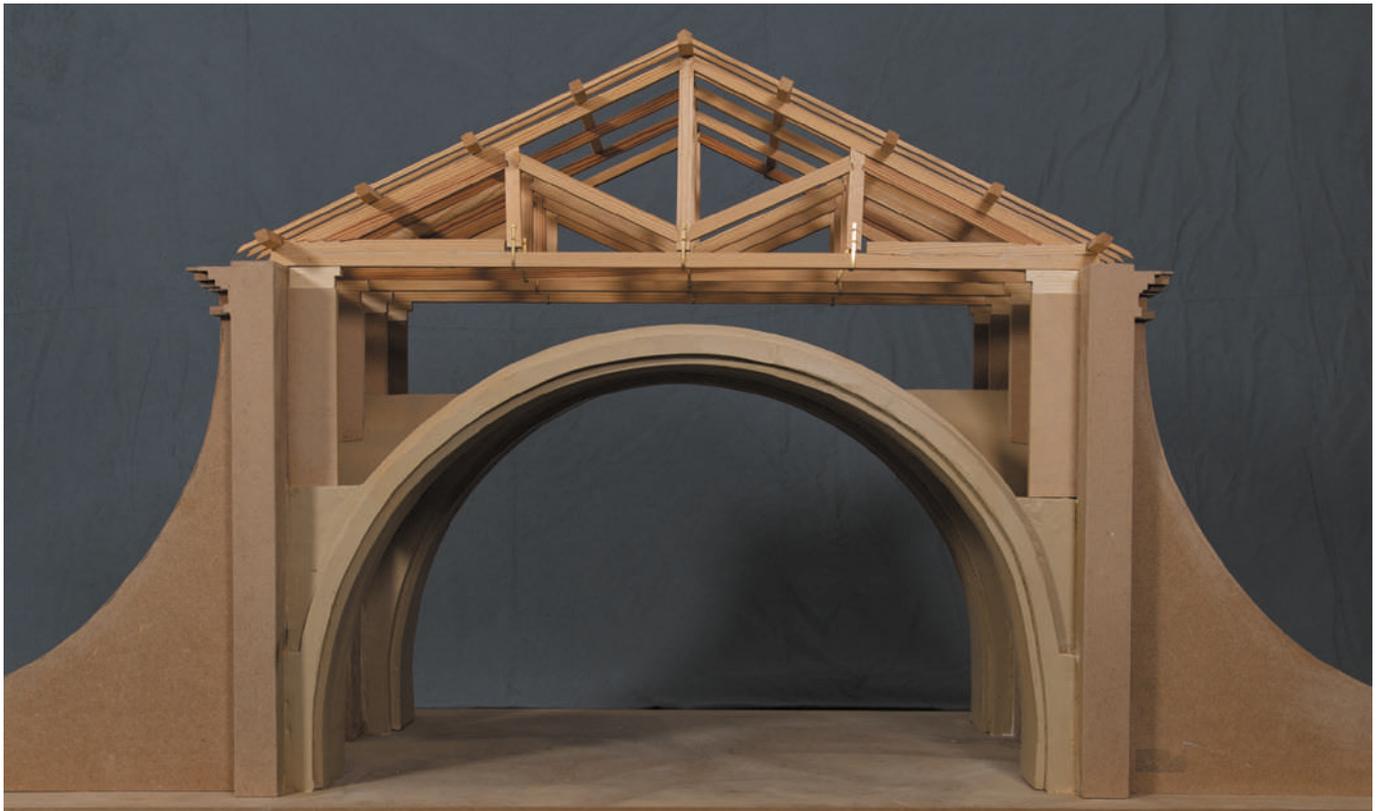
Fig. 10b. Italianate roof of the Theatinerkirche. (Model: C. Knobling, Picture: I. Mühlhaus).

The later Electress Henrietta Adelaide of Savoy wanted a thoroughly Italianate architecture for the church [6], including also a flat-pitched roof. The master builder, Agostino Barelli from Bologna, accordingly made designs that foresaw a “Palladiana”. Probably this was never realized. Sources from the Bavarian State Archives show a modified construction – a structure consisting of a central king post and two laterally queen posts, each with raking braces. The archival sources indicate that this was the construction of the 17th century. Similar schemes have already been handed down from earlier times, e.g., by Serlio and Bernardino Baldi [19]. It can be assumed, however, that the construction was substantially strengthened in the 19th century, at least at the base points. When it was built, an “Italian” purlin roof was still highly unusual in Bavaria [20]. While carpentry was mastered, sheet metal roofing still caused problems. The reason for the design of a flat-pitched roof was not only the incompatibility of a steep roof and the Italianate facade (which was not completed until the 18th century).

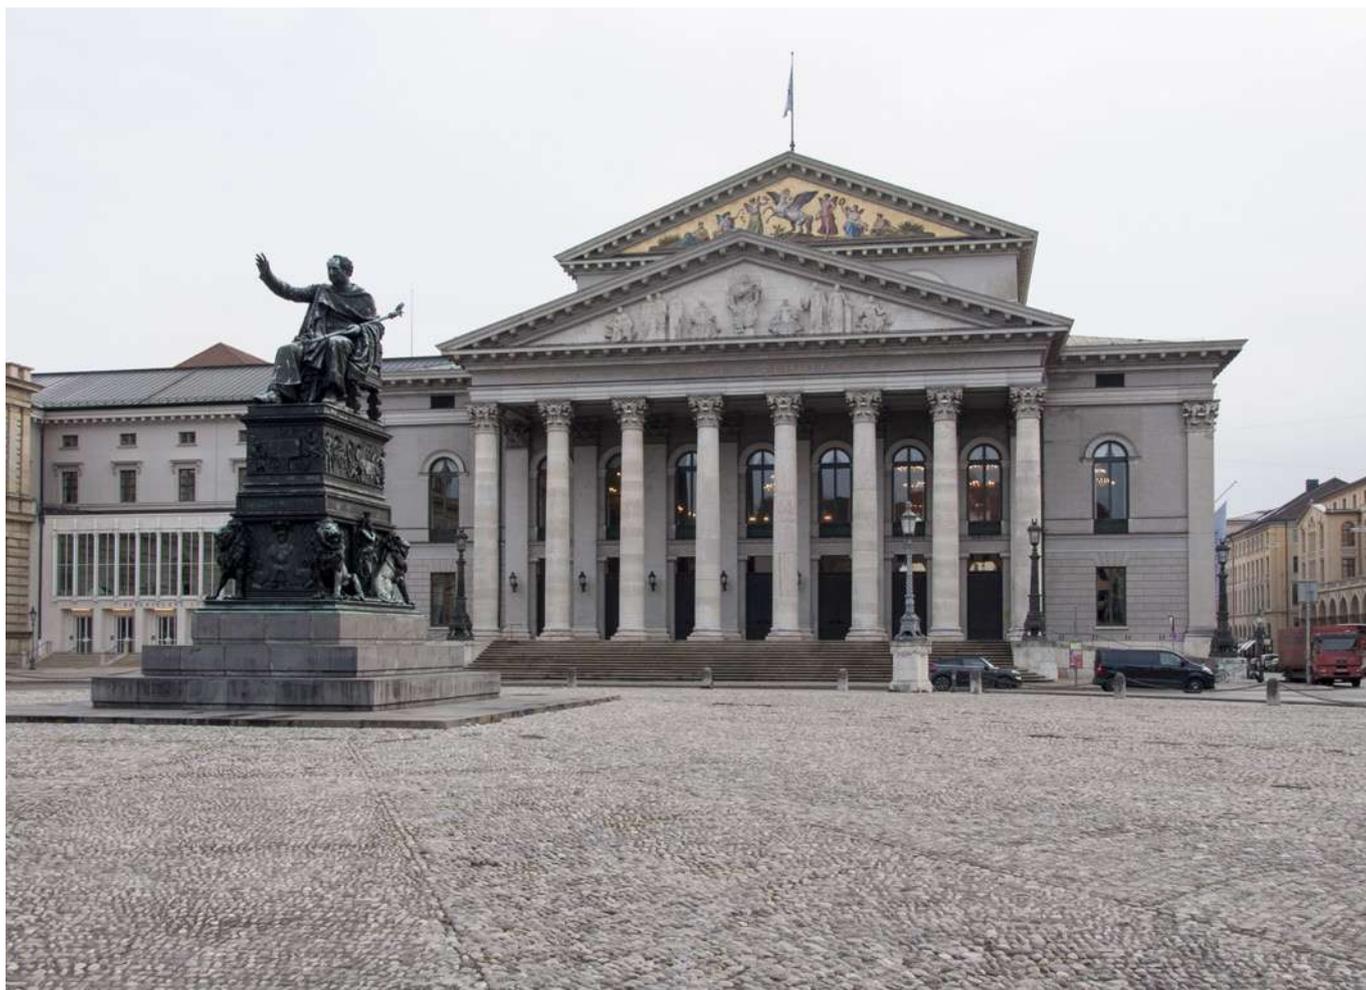
Fig. 11a. Nationaltheater (State Opera House).

construction. In order to create the necessary construction height and flat pitch of 23° at the same time, Klenze used a trick: the actual base of the roof construction was located behind a flap-tile. So the outer segments of the assembled principle rafters could be inclined somewhat steeper at 29° while the common rafters continued to the eaves at the same inclination (23°). This was also applied in other buildings of Klenze [21]. Four king posts were placed in each truss. A rod polygon transferred the loads from the king posts to the supports. The king posts were assembled of two parts each. Thus, they could embrace both the rafters and the rod polygon. The tie beams were assembled of five individual parts, which were connected with dowels [22–24].

Underneath the roof, there were further trusses to carry the floor of the painters' hall as well as the vaulted ceiling of the auditorium below. Since the trusses rested on the circular enclosure of the auditorium, each had a different free span. Thus, Klenze constructed different types of constructions for each span. A ring, which held the girders of the plafond of the auditorium, was fixed in the middle of the two central trusses. The vaulted plafond

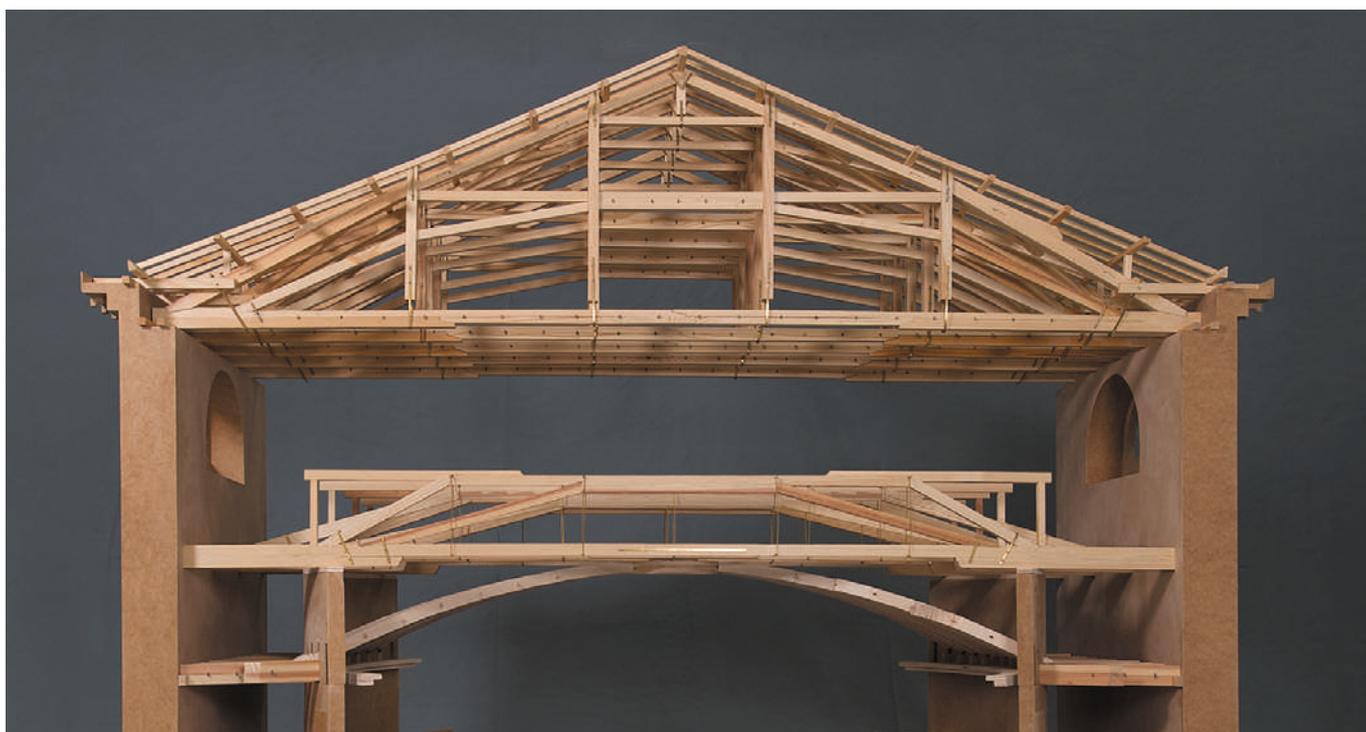
Fig. 11b. Roof construction and trusses of the ceiling of the auditorium of the Nationaltheater. (Model: C. Knobling, Picture: I. Mühlhaus).

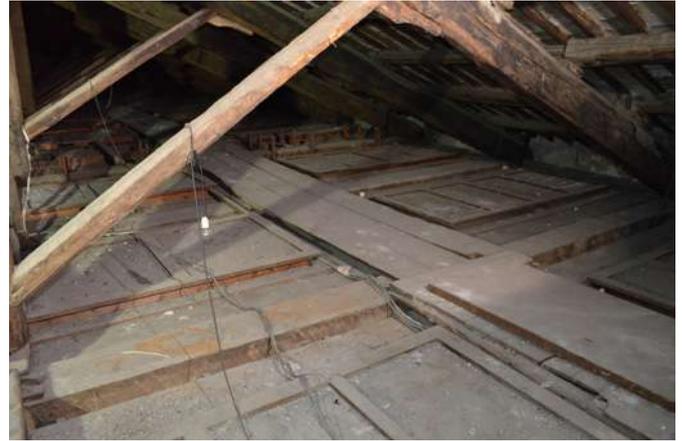
Fig. 5. Rome, San Vitale in via Nazionale; extrados of the coffered ceilings (1933-1934).

Considering that the coffered ceilings examined were inserted in existing buildings, we can assume that the trusses supporting the roof were already present; consequently, the workers were forced to work in a given situation. So, after the architect designed the ceiling, in its general lines describing the coffers, the *faber lignarius* considered the number and spacing of the existing trusses to achieve the assembly, covering the trusses directly or hanging the ceiling from them. The covering system, commonly used in 15th century Roman churches, is also used in the ceiling of San Vitale in via Nazionale, which was built in 1934; all other coffer ceilings, whose external structures were explored, are made following the hanging system. The decoration scheme of the ceiling in San Vitale shows three longitudinal bands – the central one is the largest – in a checked pattern of rectangular coffers. In this scheme, false transverse trusses are positioned according to the spacing between the upper trusses. The boards forming the false trusses are nailed to the beams, and the bottom boards of the coffers are nailed to them, also by shims (Fig. 5).

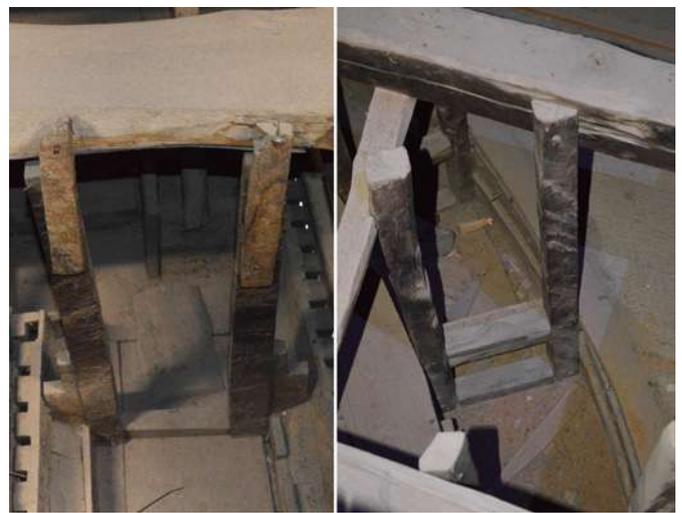
Fig. 6. U-shaped frame detail. On the left, frame with a crossbar (Rome, San Bartolomeo all'Isola, 1623-24); on the right frame with two cross-pieces (Ss. Cosma and Damiano, 1632).

ble system, offering more freedom in constructing the wooden roofs. On the other hand, by adding sleepers above the joists, hanging frames not in vertical correspondence with them is possible. The frames analyzed can be grouped into three classes: the first one including U-shaped devices, consisting of two uprights and one or more cross beams (Fig. 6); the second also concerning

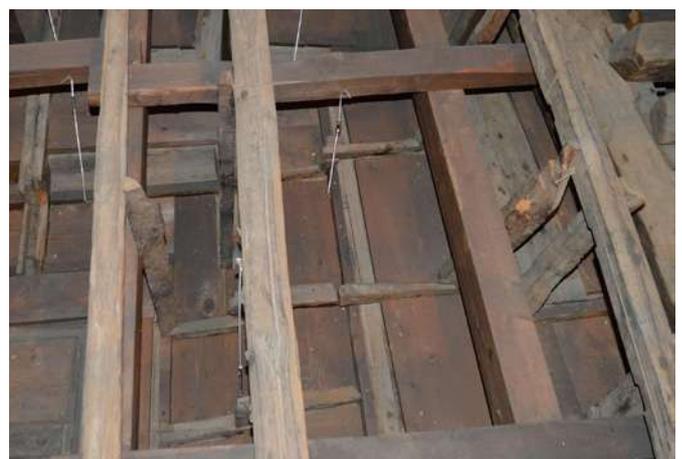
Fig. 7. U frame with a crosspiece made up of several elements connected to each other in a staggered form. The picture shows the reinforcement work carried out about ten years ago, proving the insertion of a little reinforcing steel with double screw clamps for the anchorage of the bottom. In fact, the ceiling presented a marked transversal viscous deformation accompanied by localized subsidence (Rome, San Silvestro al Quirinale, 1573).

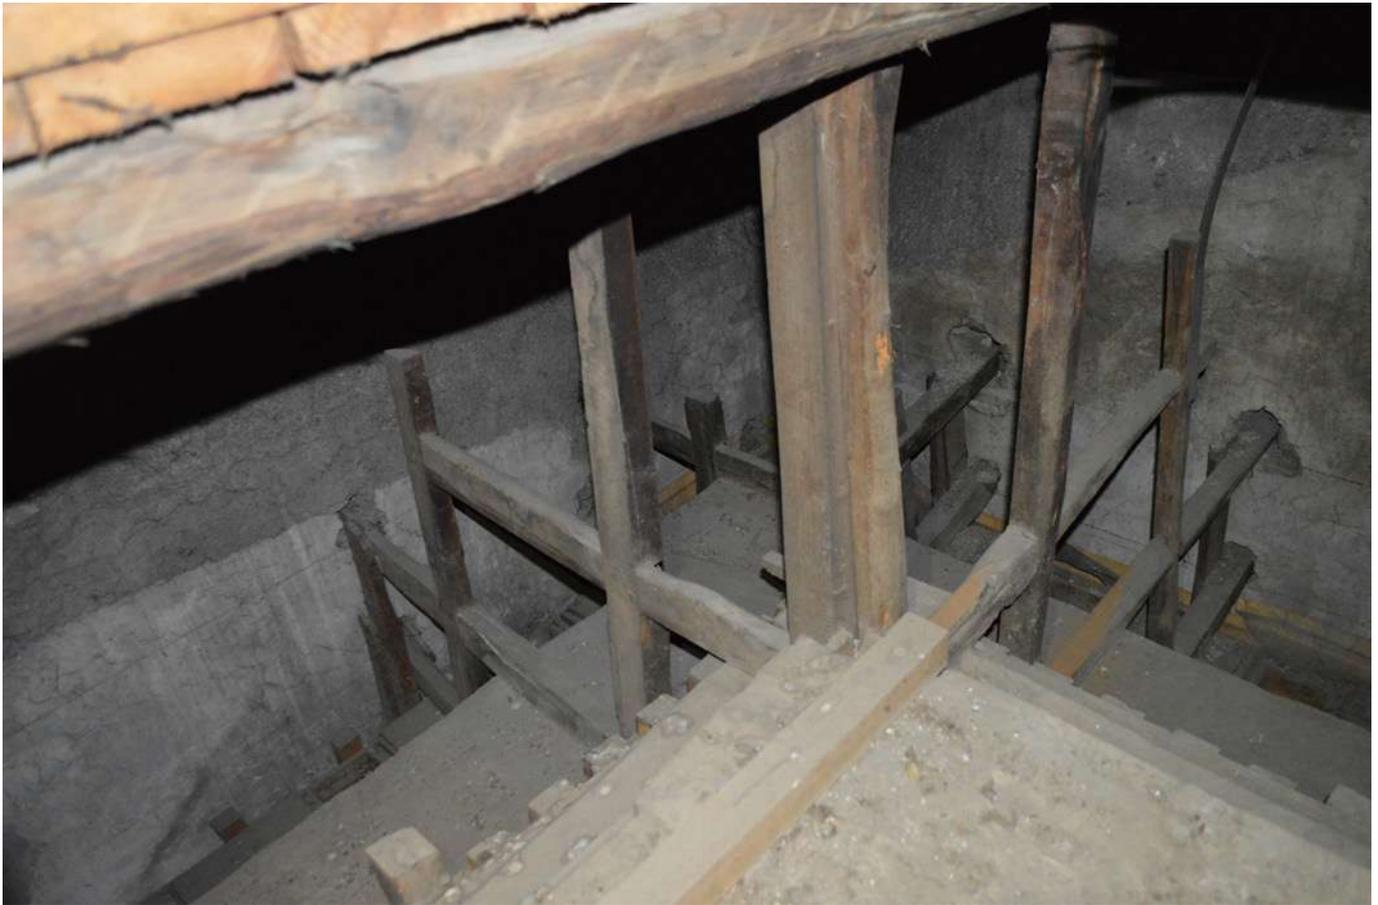
Fig. 8. L-shaped perimeter frame anchoring the ceiling to the perimeter walls (Rome, Santa Maria in Trastevere, 1617).

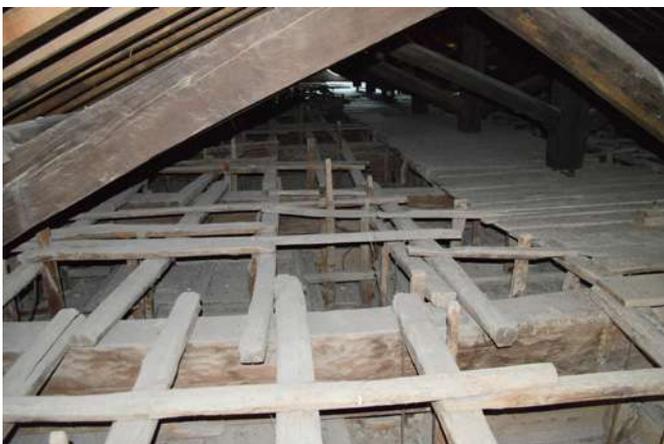
Fig. 10. Ceiling without upper wooden deck with non-uniform arrangement of joists (Rome, Sant’Agnese fuori le mura, extrados of the coffered ceiling, 1606).

The frames, or the individual panels, determine the arrangement of the upper joists. When considering these elements, two factors are crucial, although they do not affect the quality of the ceiling: the spacing of the trusses and a walkable wooden surface above the joists. In case of a short distance between the trusses and the absence of a walkable surface, the joists have a small section (about 6 cm x 6 cm), rough in shape, not squared; moreover, their positioning is due to the need to hang the uprights below. The result is an irregular and uneven arrangement that, in some cases, is not perfectly orthogonal with respect to the tie beams of the trusses (as in Sant’Agnese fuori le mura, 1606) (Fig. 10). Moreover, a more regular arrangement of the joists emerges in trusses with a wide center-to-center distance. However, in both situations, the joists are not nailed to the beams, wrapping them, but just leaning on top. Differently, realizing a walkable surface requires a maximum distance between joists of 50 and 60 cm to nail the planks over them. Therefore, the frames for hanging the ceiling are not directly related to the joists and the insertion of crosspieces – below the beams or at the same height – is necessary to fix the hangers in the intermediate spaces (an example is the coffered ceiling of San Giuseppe dei falegnami (Fig. 11).

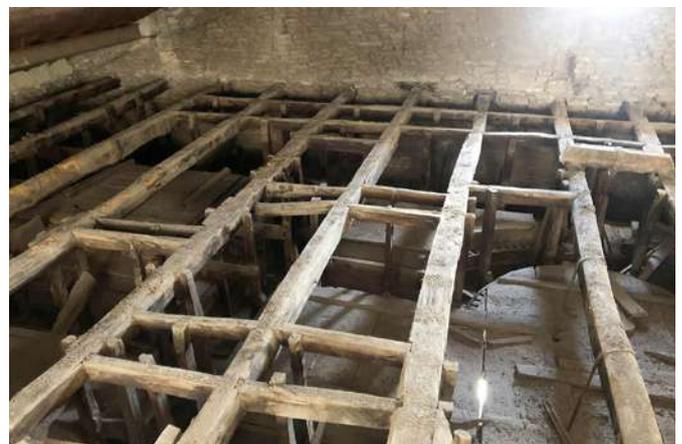
Fig. 11. Ceiling covered by a walkable floor, made by joists placed on regular distance, to which the U-shaped or L-shaped frames of the ceiling are hung by crossbeams (Rome, Extrados of the ceiling of San Giuseppe dei Falegnami, 1612).

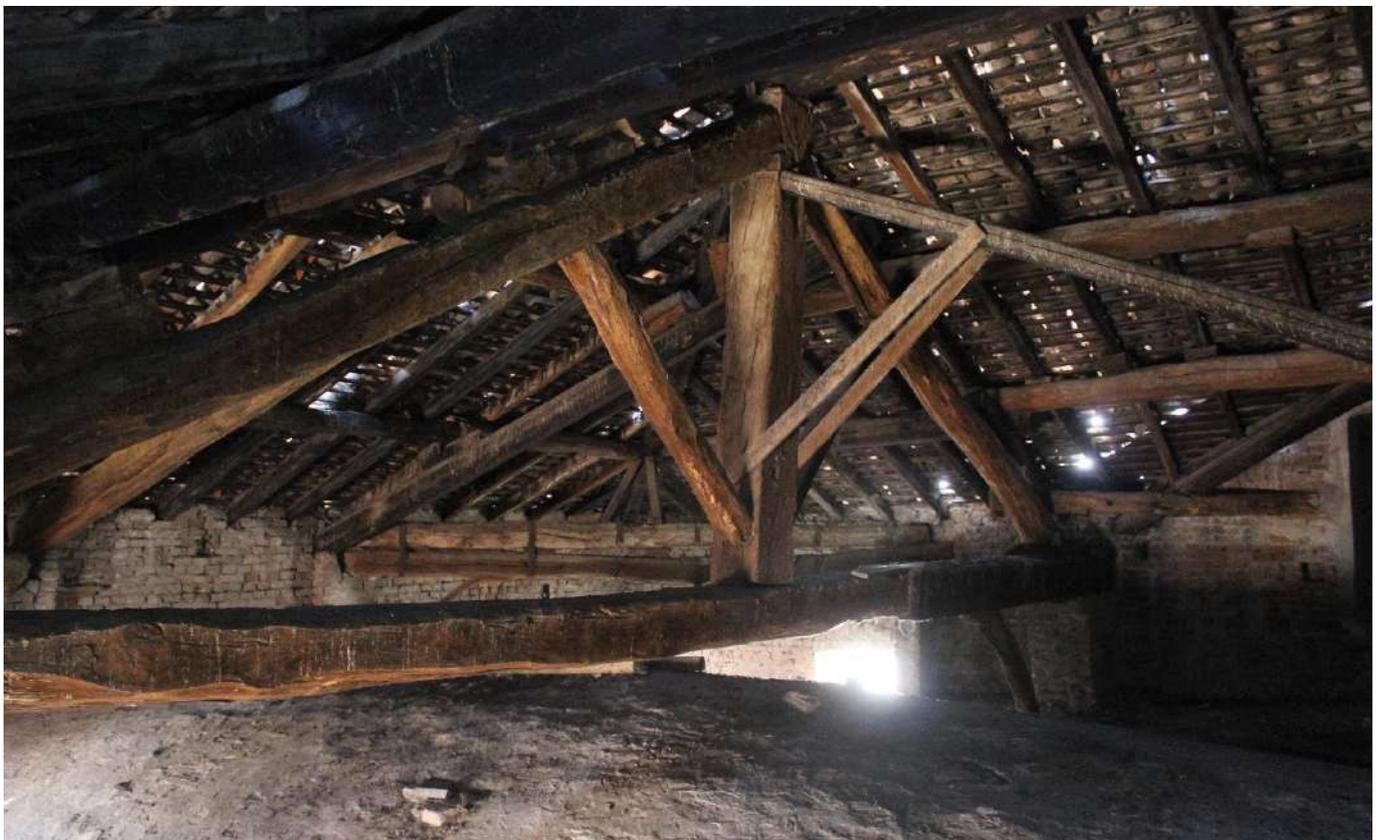
Fig. 3. Closed joint king post truss in the attic above the presbytery of the church. (Photo by Emanuele Zamperini).
