**Remarkable historic timber roofs. Knowledge and conservation practice.
PART 1 - Construction history and survey of historic timber roofs**

TEMA
Technologies
Engineering
Materials
Architecture

**Remarkable historic timber roofs. Knowledge and conservation practice
Part 1 - Construction history and survey of historic timber roofs**

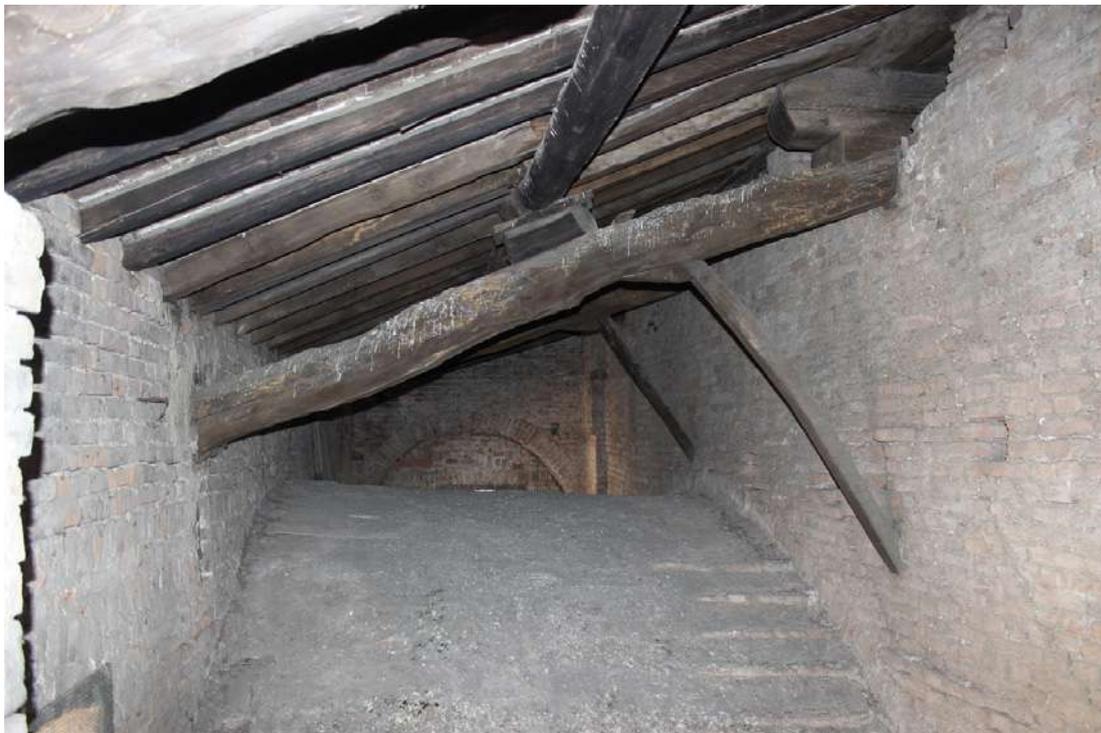
Fig. 4. Roof of the band on the northern side of the nave; it is possible to see the extrados of the barrel vault of the pseudo transept. (Photo by Emanuele Zamperini).

The roof structure of the side chapels is simpler, consisting of rafters (generally placed in correspondence with the trusses of the nave, but some are probably added later

and placed between those) which support a single purlin placed in the middle of the pitch on which the joists rest. The rafters and the purlins are almost all made of oak timber, but some of them – probably even these still original – are made of larch, and others of spruce, which are probably recently replaced or added. The joists are mainly made of oak and discontinuous in correspondence with the purlin, but there are some made of poplar and some others of spruce which are recently added and usually continuous on the two spans. In this part of the roof, no significant differences are visible between the two construction phases of the church.

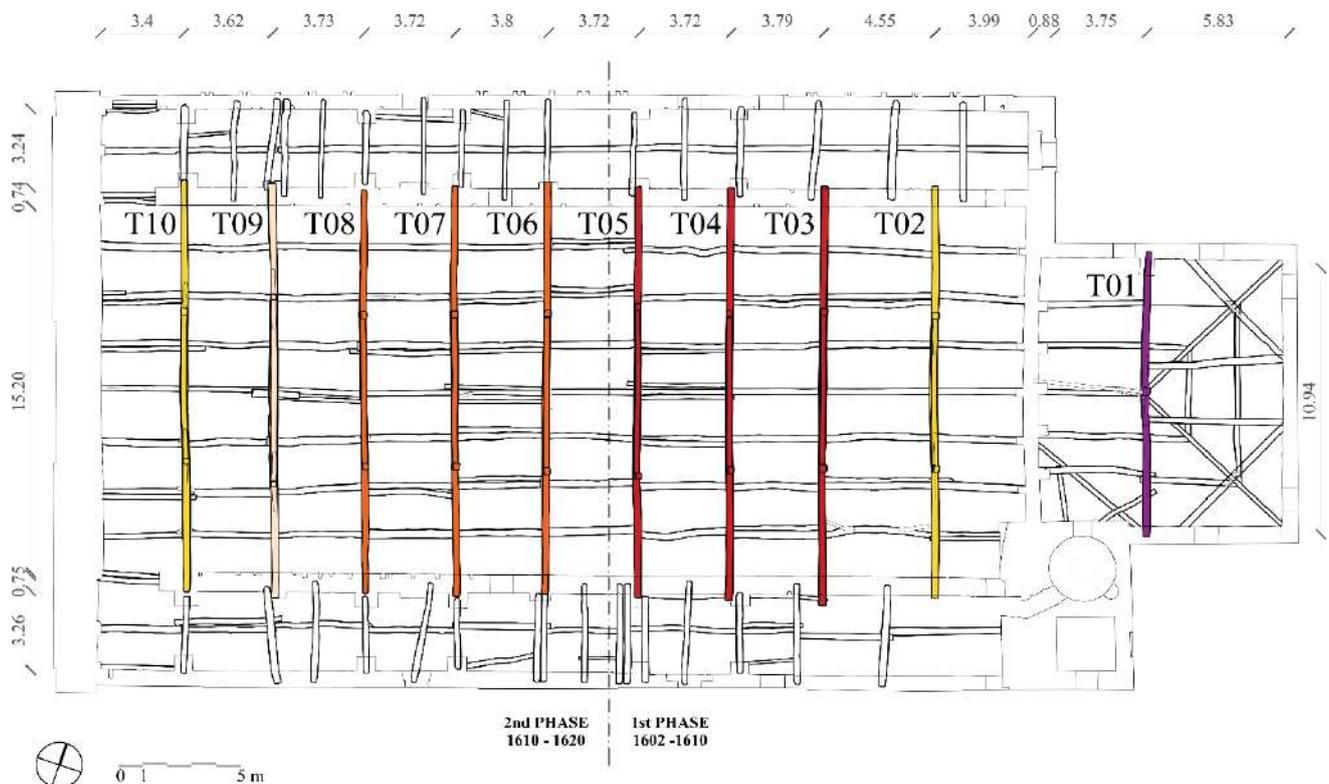
Fig. 5. Plan of the roof structure. (Geometrical survey: Courtesy of R.T.C. di Colturato & Pedrini). In purple the king post truss of the roof of the presbytery (T1); in red the Palladian trusses of the first phase in which the queen posts rest on the tie-beam (T3-T5); in orange the Palladian trusses of the second phase in which the queen posts are linked to the tie-beam with tenon-mortice joints (T6-T8); in pink the Palladian truss reworked probably in the first decades of the 19th century with queen posts detached from the tie-beam (T9); in yellow the Palladian trusses reworked in 1841 with queen posts detached from the tie-beam (T2 and T10).

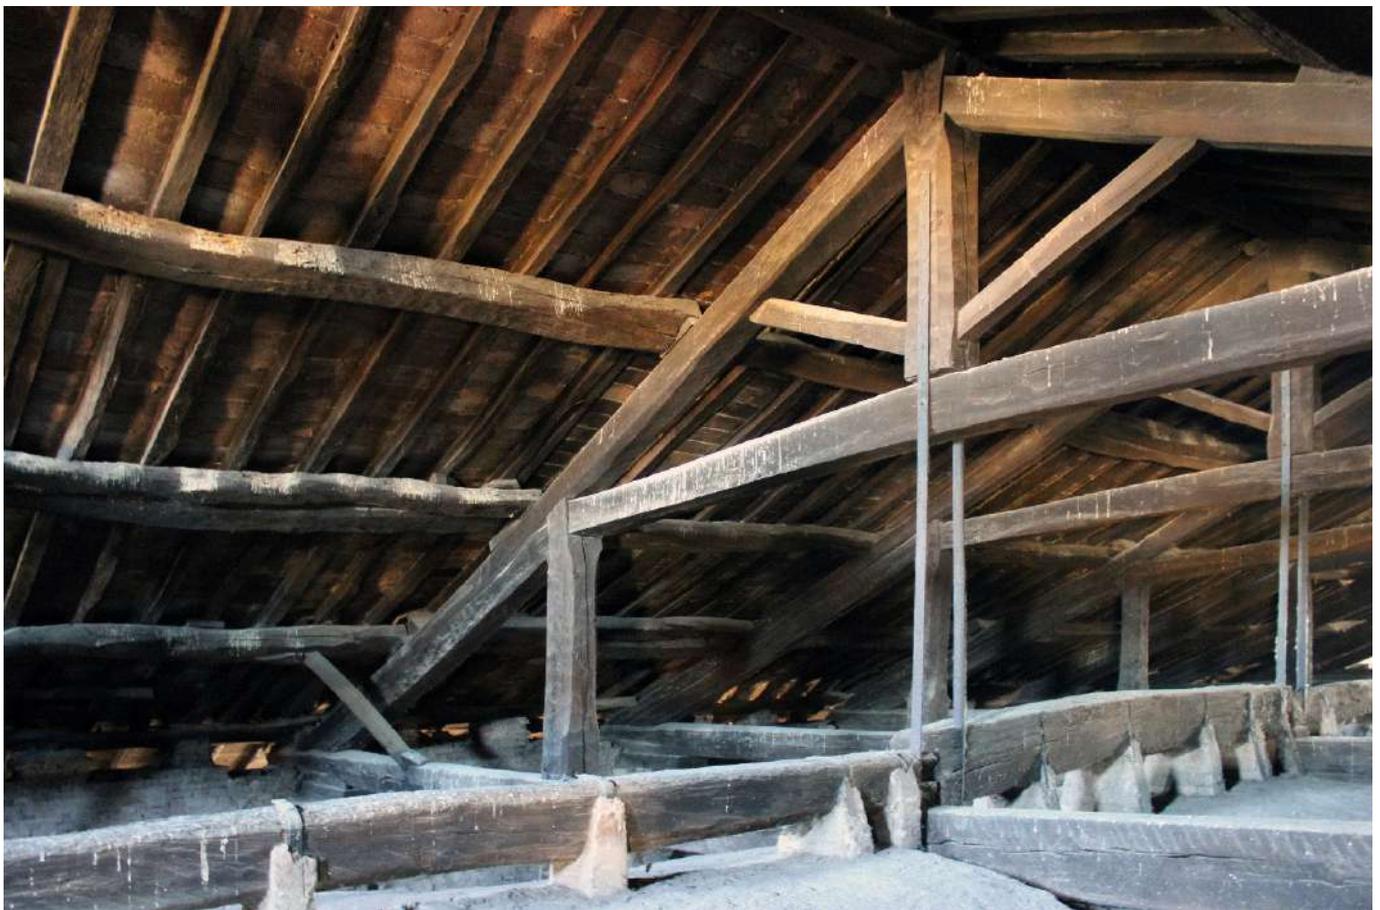
Fig. 6. Unmodified truss of the first phase: T3 truss seen from the north-east. (Photo by Emanuele Zamperini).

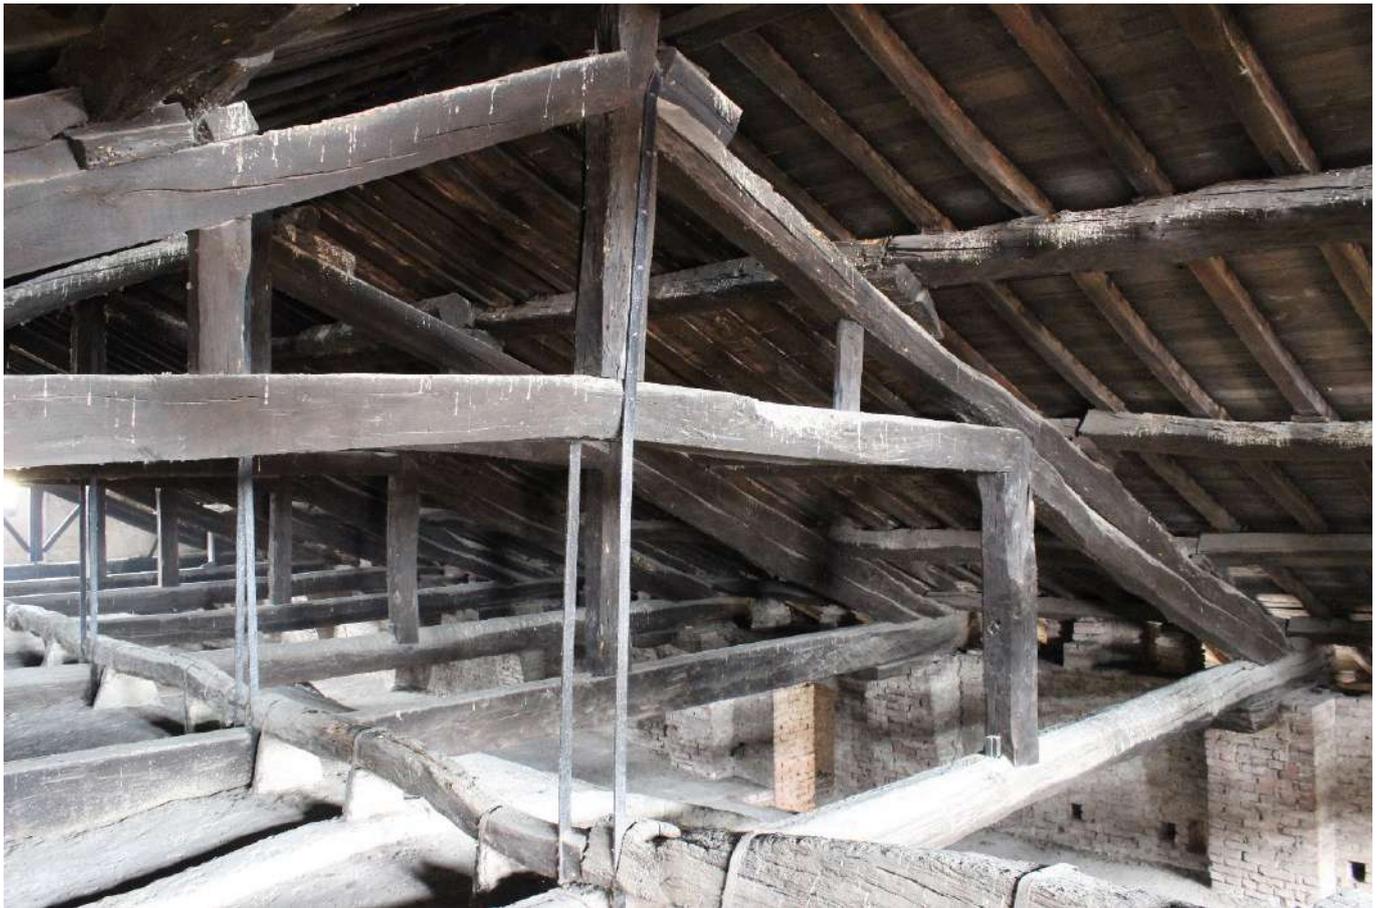
Fig. 7. Unmodified truss of the second phase: T8 truss seen from the north-west. (Photo by Emanuele Zamperini).

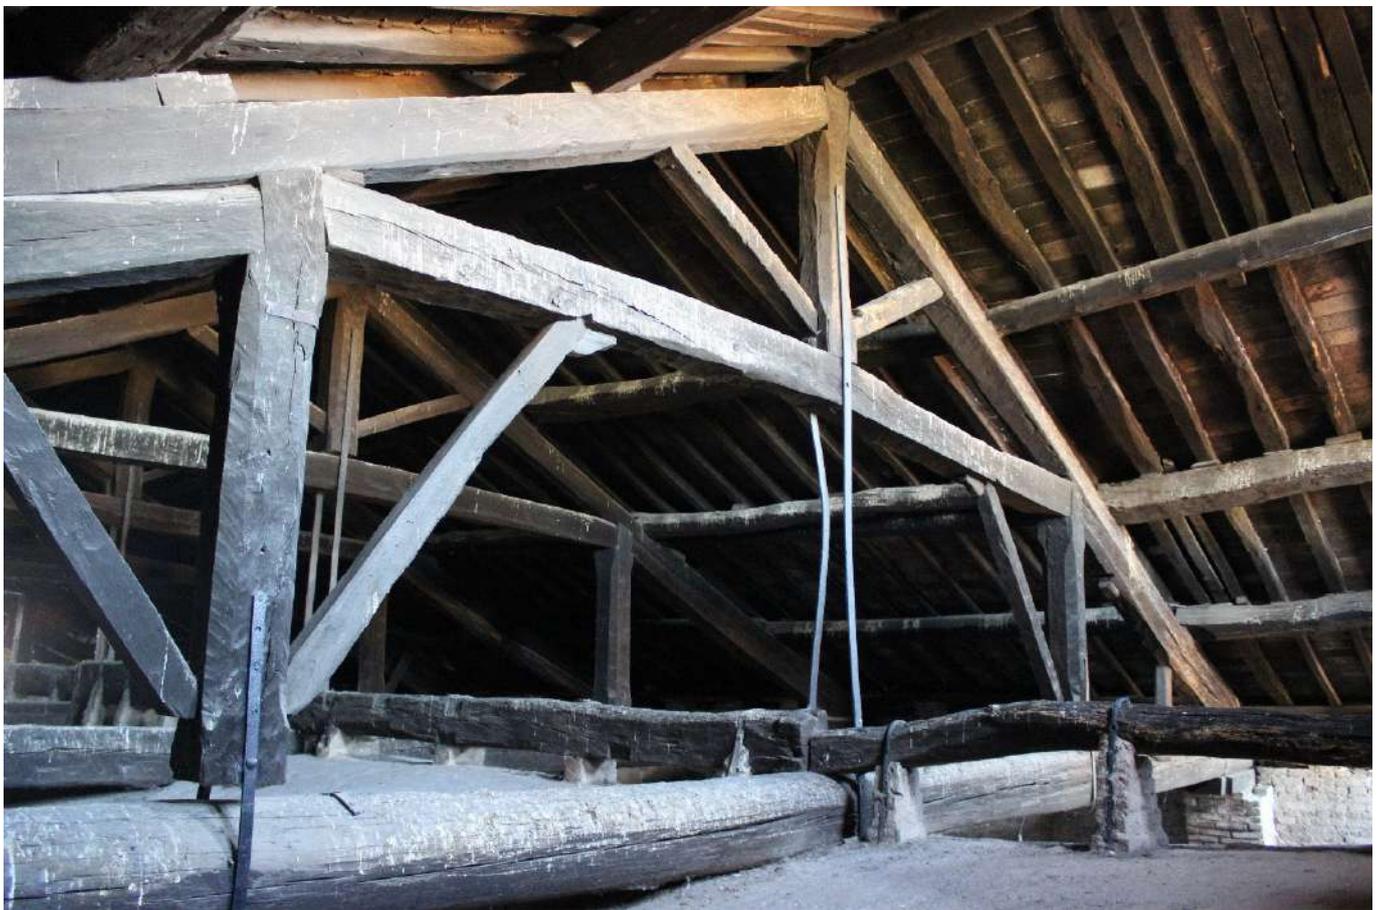
Fig. 9. Modified truss of the first phase: T2 truss seen from the south-east. (Photo by Emanuele Zamperini).

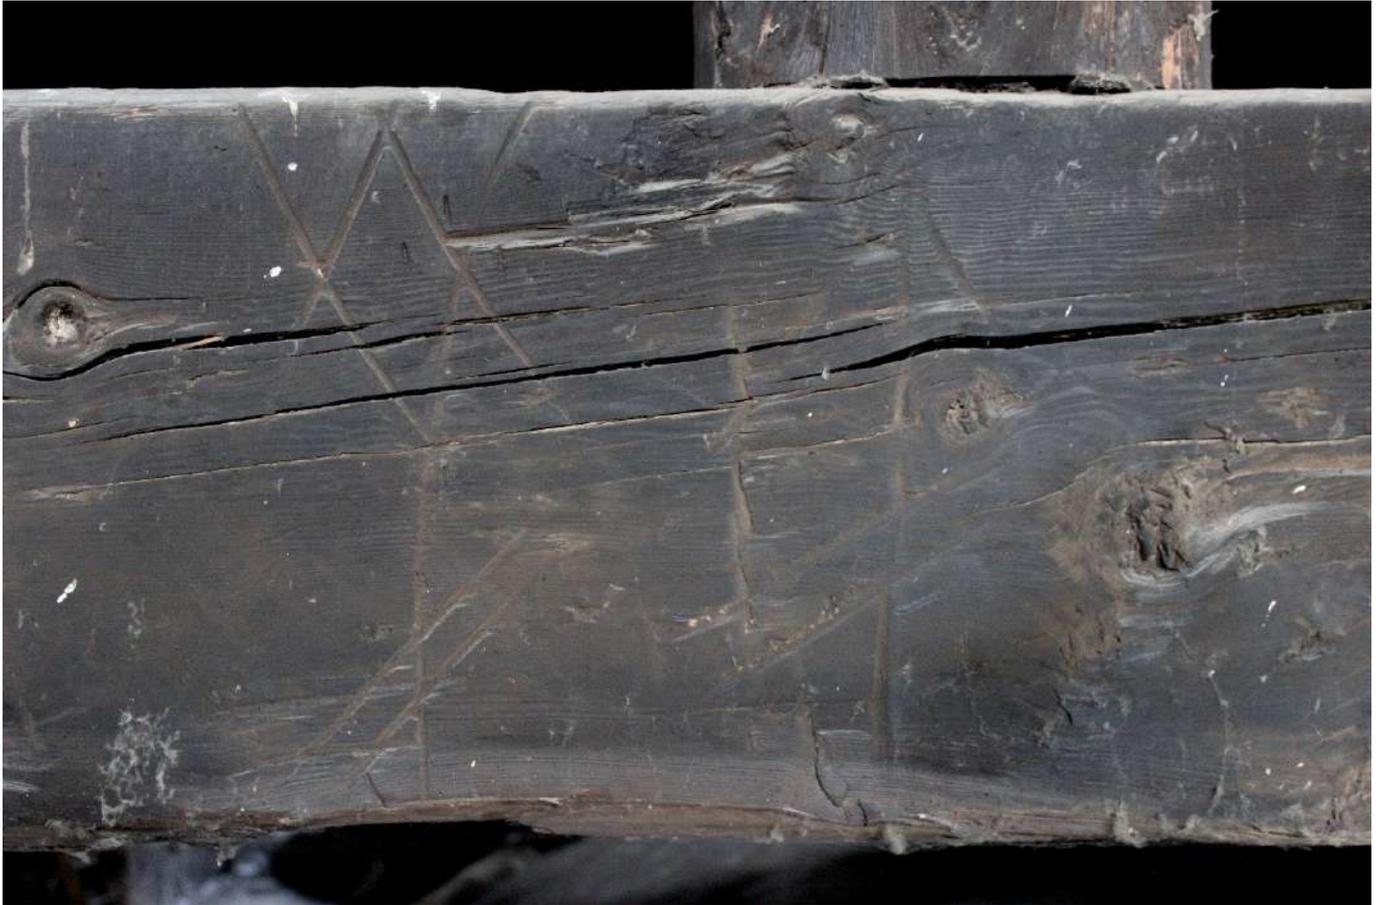
Fig. 11. Trading mark on the west side of the tie-beam of the T7 truss. (Photo by Emanuele Zamperini).
