**VOL. 8, SPECIAL ISSUE (2022)**

**Remarkable historic timber roofs. Knowledge and conservation practice.  
PART 2 - Investigation, analysis, and interventions**

**TEMA**  
Technologies  
Engineering  
Materials  
Architecture

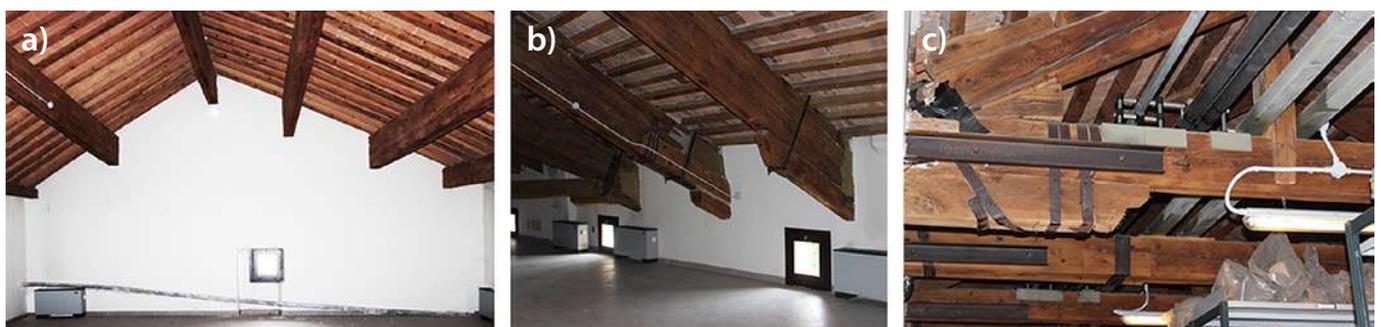
Fig. 4. Timber roofs types: (a) large-span timber purlin roof built with the “trave composta” technique; (b) timber rafters roof made with the “trave composta” technique; (c) a small-span king trusses roof with reinforcement.

This type of roof is employed for gable roof portions with small spans (550-750 cm), distanced about 170 cm. Joists are parallel to the ridge. Joints between the rafter and tie-beam were reinforced laterally with C-shaped metal elements connected with masonry. Some trusses are supported by a corbel, connected with the tie-beam by means of iron strips (Fig. 4c).

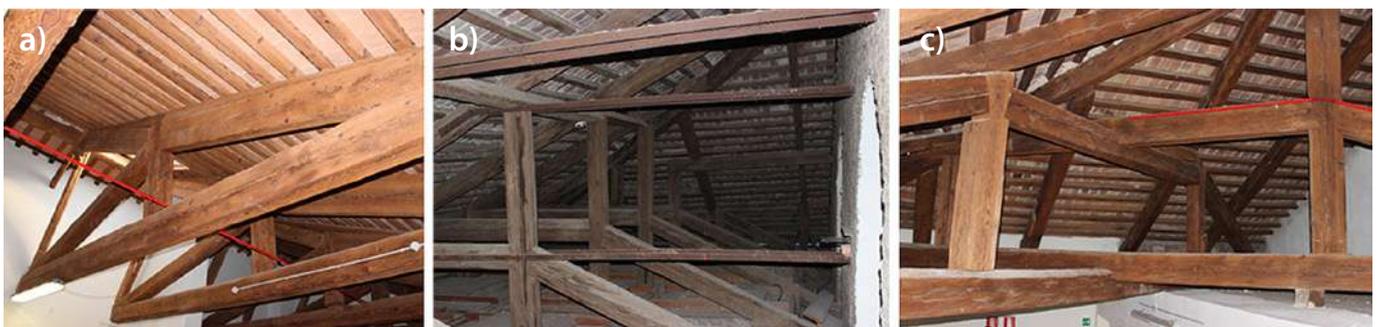
Fig. 5. Timber roofs types: (a) asymmetrical king trusses; (b) asymmetrical queen trusses reinforced with fitch plates at the joints and a double layer of tie rods; (c) intersection between asymmetrical queen trusses.

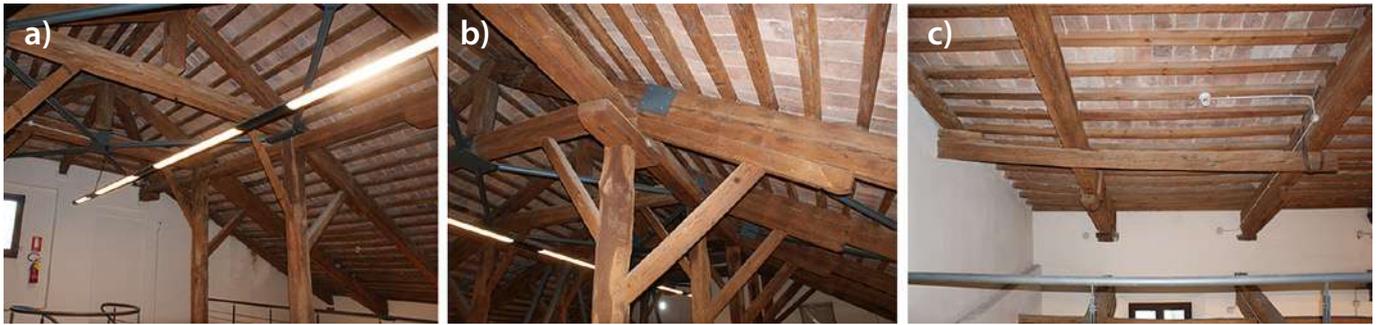
Fig. 6. (a) Timber rafter roof with crown posts; (b) connection between collar purlins highlighted by the presence of a wooden capital; (c) previous reinforcement for excessive deformation.

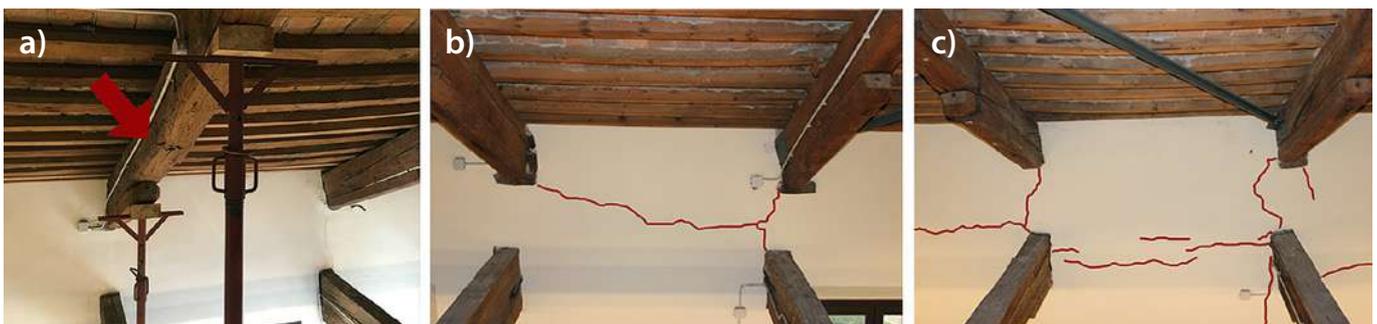
Fig. 7. Seismic damages: (a) cracked rafter; (b, c) horizontal masonry cracks on longitudinal walls.

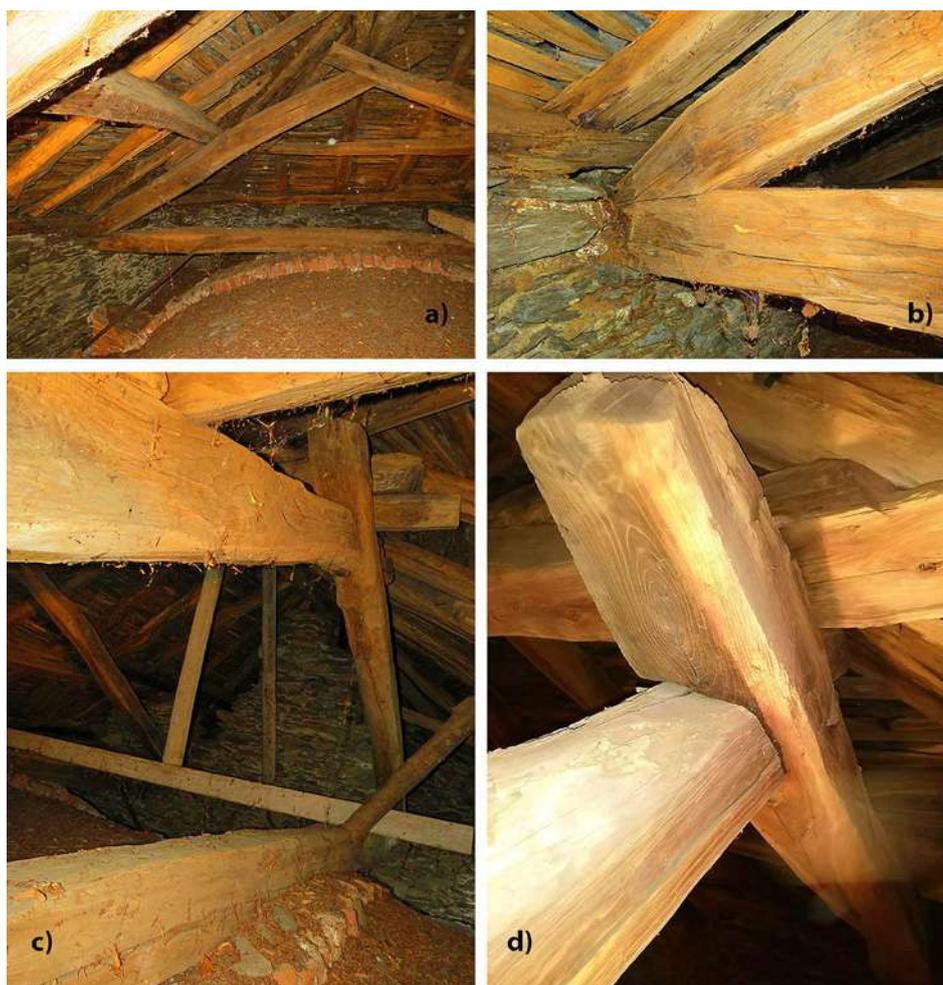
Fig. 5. (a) North truss; (b) detail of the tie beam-rafters connection, in evident degradation inside the masonry support; (c) tie beam rests on the extrados of the vaults; (d) detail of a half-lap coupling connection.

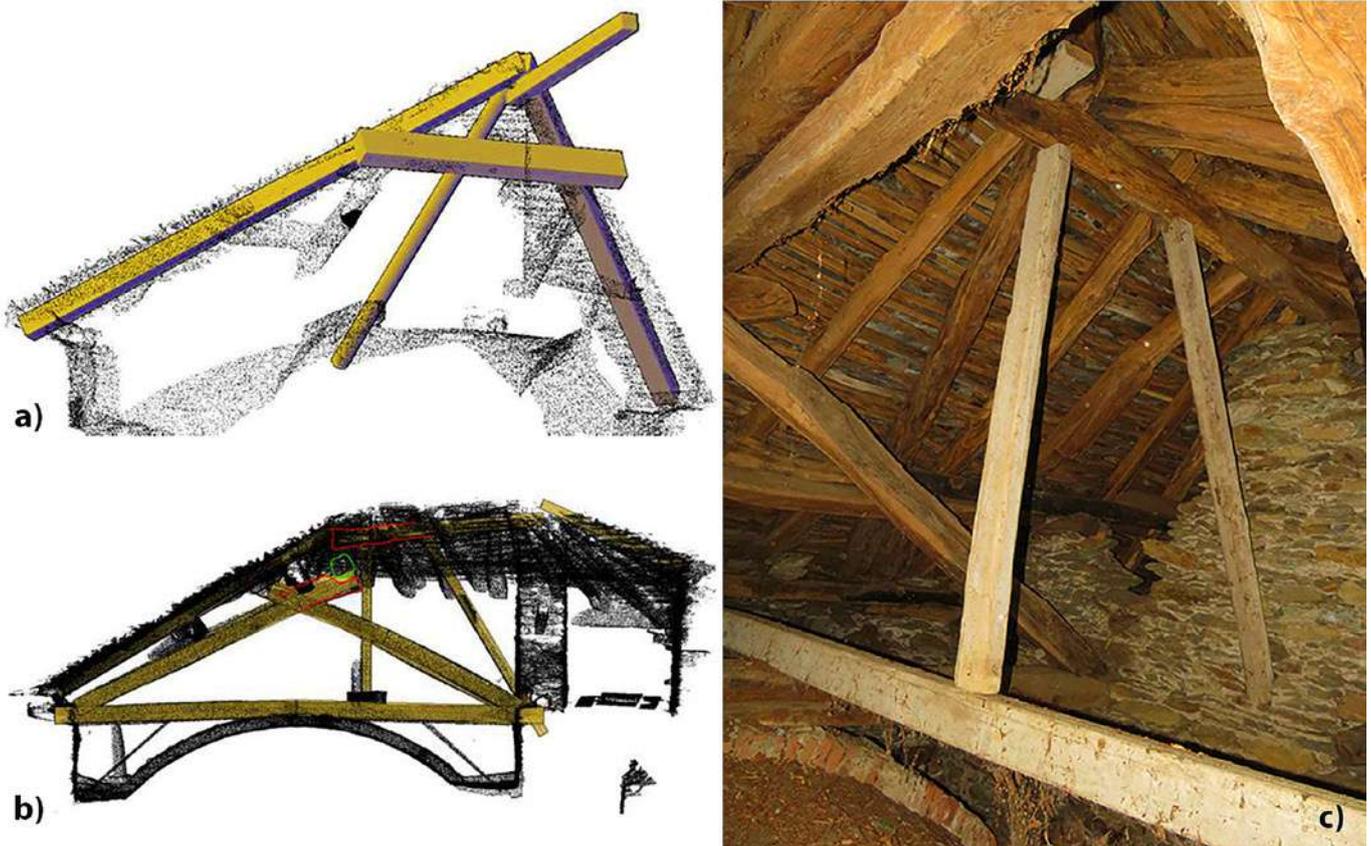
Fig. 6. (a) Laser scanner survey of the roof area, including the two cantonal beams; (b) hypothesis of the original configuration of the ridge beam; (c) props to support the ridge beam.

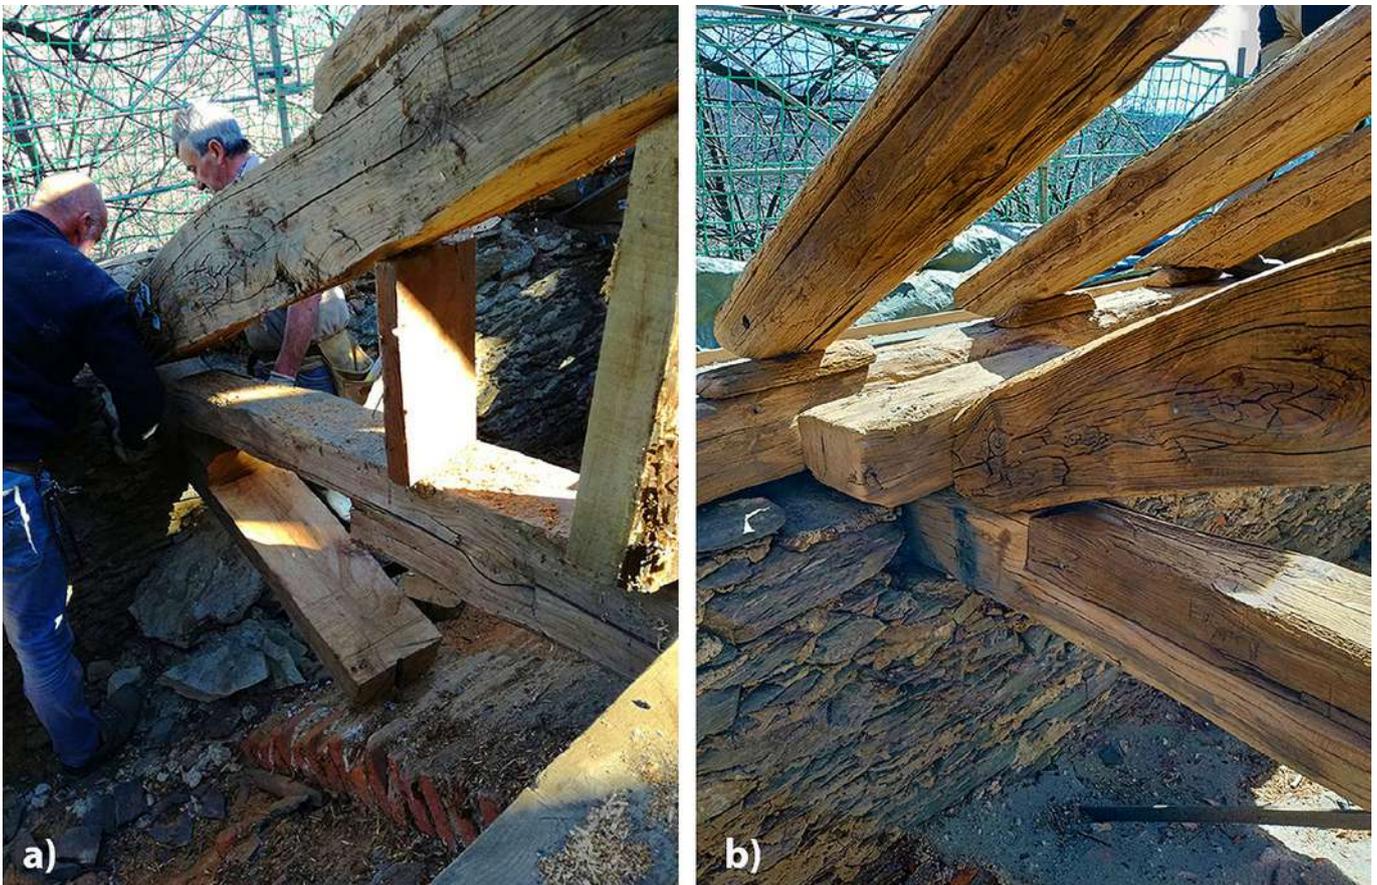
Fig. 9. (a) Positioning of the timber prosthesis; (b) the timber-timber prosthesis performed.

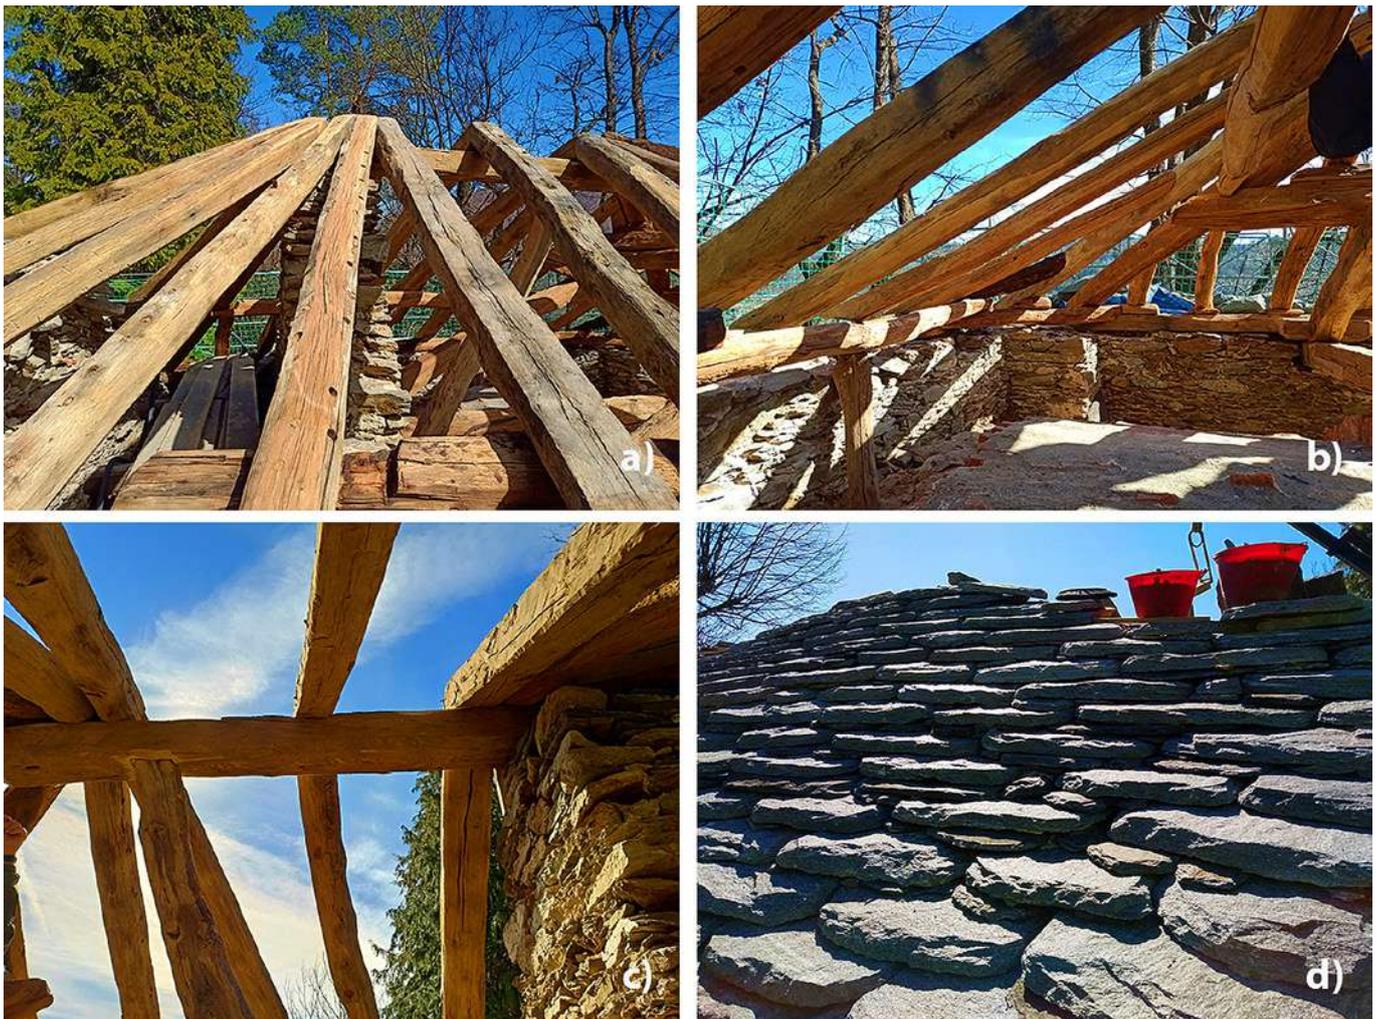
Fig. 10. (a) Placement of new timber elements alongside the original ones cleaned up; (b) integration of the new quay beams into the original structural scheme; (c) cleaning and static improvement of the area around the ridge beam; (d) reconstruction of the original stone roof covering.

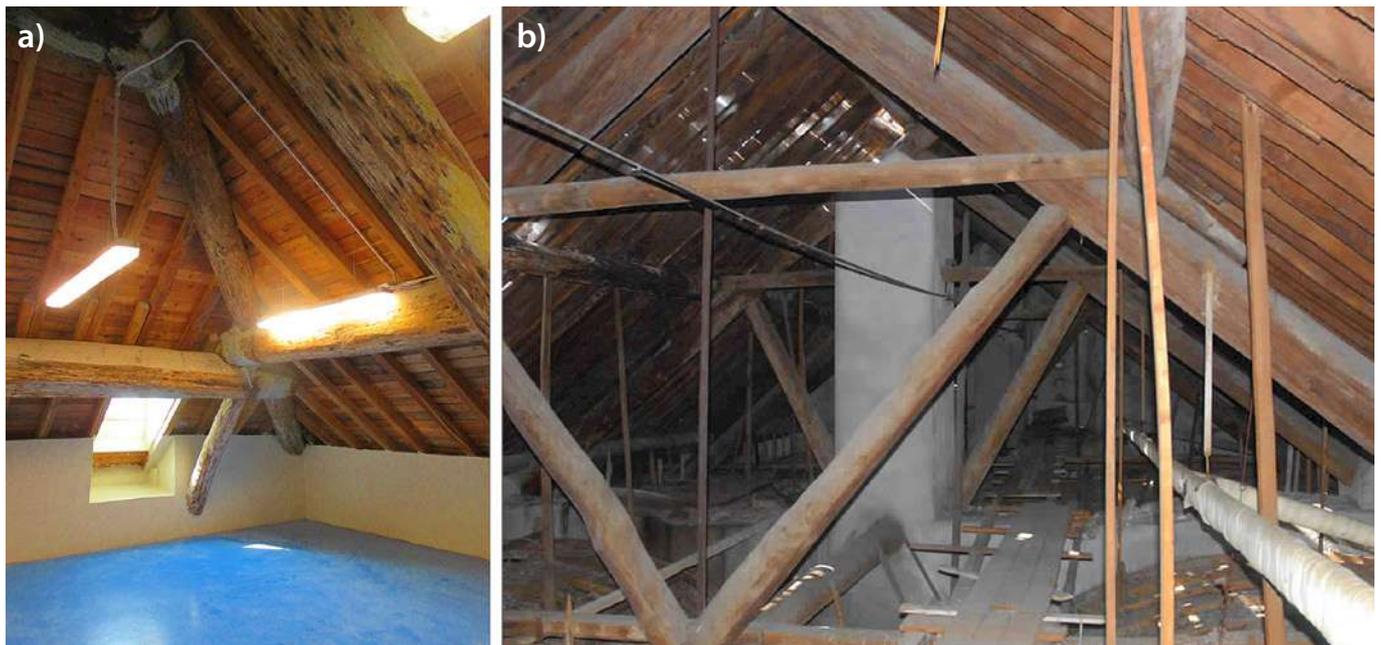
Fig. 1. Examples of the two types of roof structures present in the Albergo dei Poveri complex: (a) the roof structure of the west tower in the south wing of the complex; (b) the roof structure of the west side of the north wing.

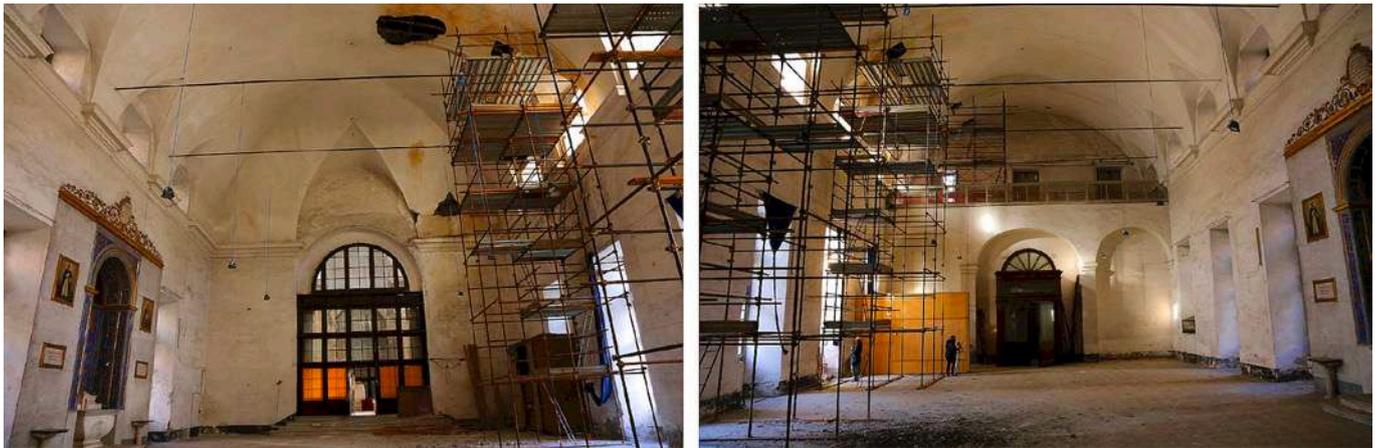
Fig. 3. East and West views of the men's Oratory.

the complex (Fig. 3). This wing is, in fact, reduced to a two-level corridor connecting the north wing to the south entrance building. The ground floor corridor is covered by solid brick cross vaults, while on the first floor, the pattern described above is repeated, and the cross vaults are made of wooden ribs and mats, anchored to solid brick transverse arches supporting the roof structures. In the large room of the former Oratory, the corridor of the upper floor opens up with a balcony that allows a view of the room below and the high altar of the church.

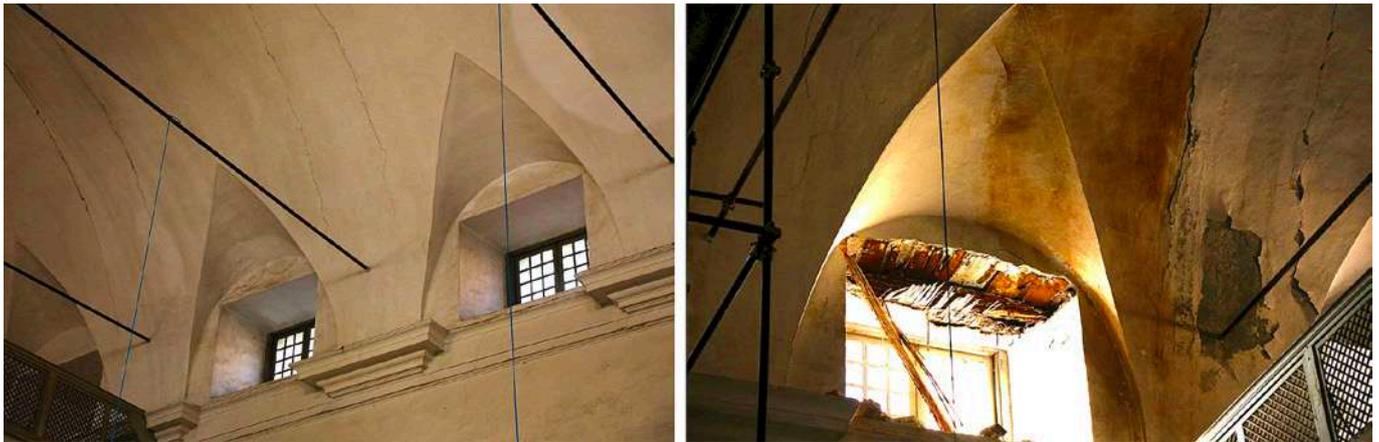
Fig. 6. Longitudinal cracks in correspondence of the arches and partial lack of the wattle of the ceiling above a window on the south side.

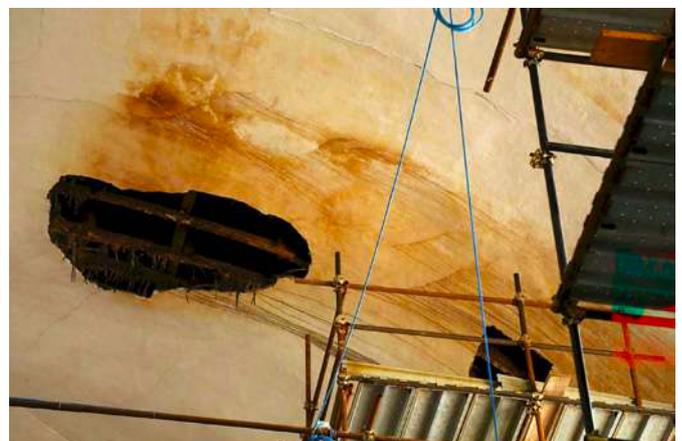
Fig. 7. Detail of the vault with the collapsed portion of wattle and plaster.

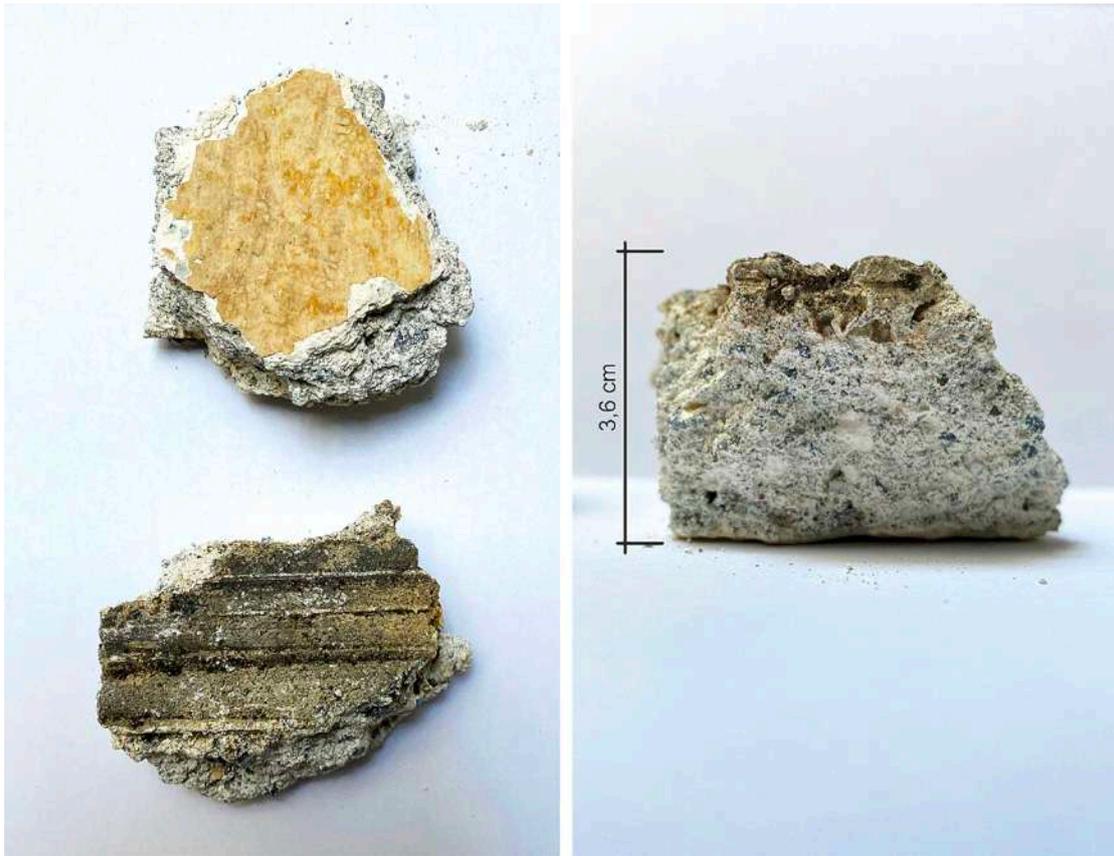
Fig. 8. Detailed photo of a portion of plaster of the timber structure vault.

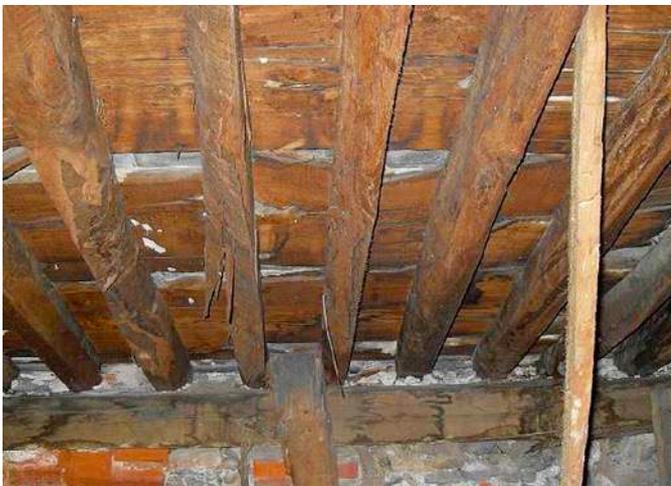
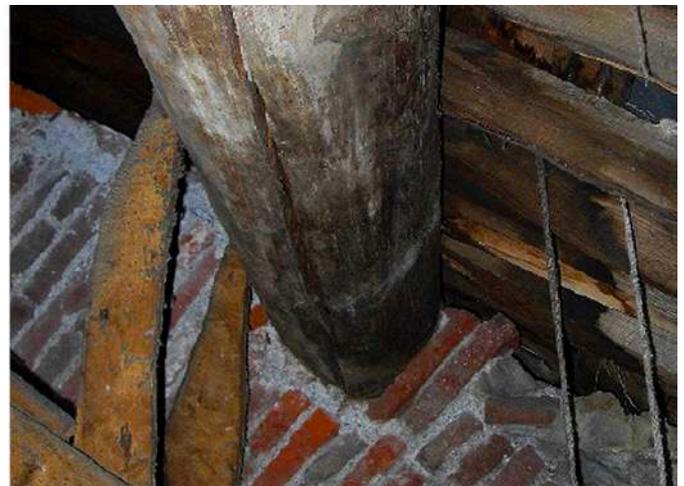
Fig. 9. Cracks and rotting of the rafters.

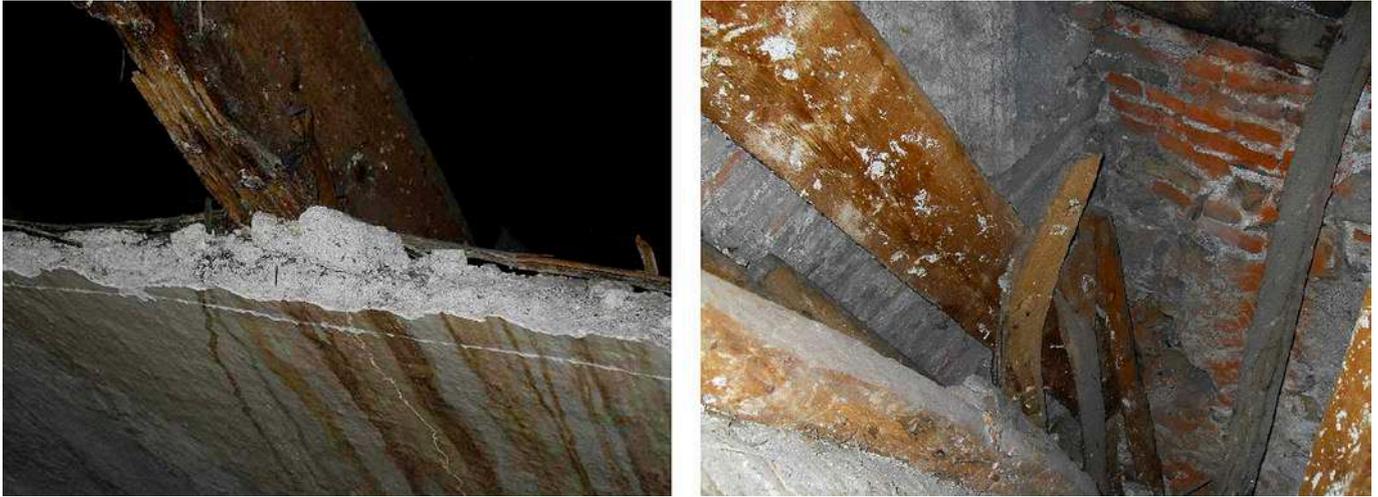
Fig. 10. The collapsed area of the vault and masonry wattle and disjoining in the support area of the struts.

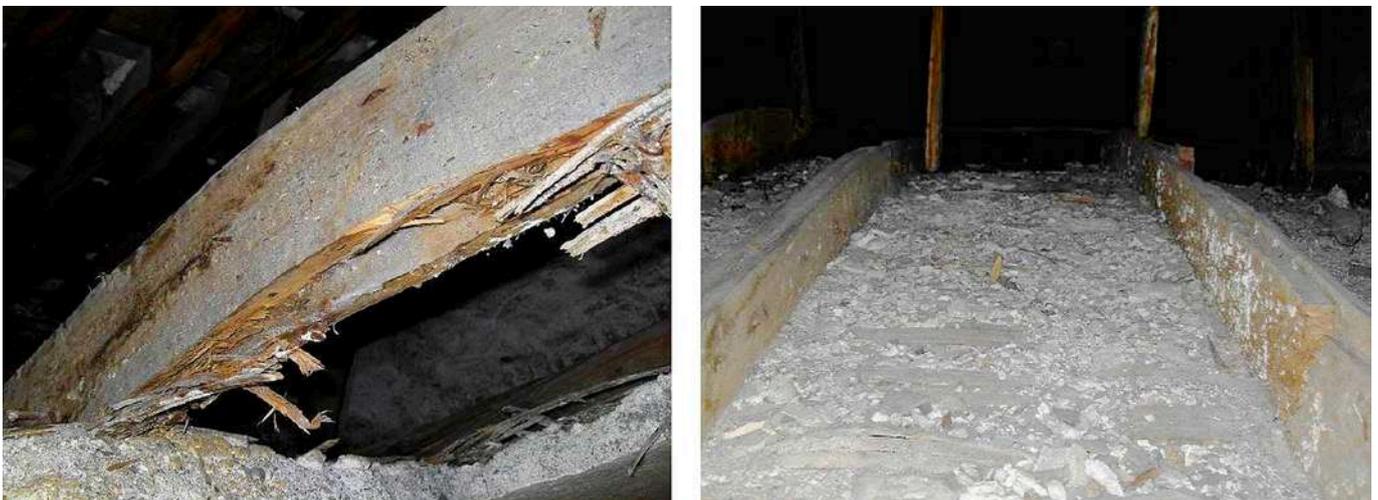
Fig. 11. Degradation of the ribs and presence of loose material on the vault.

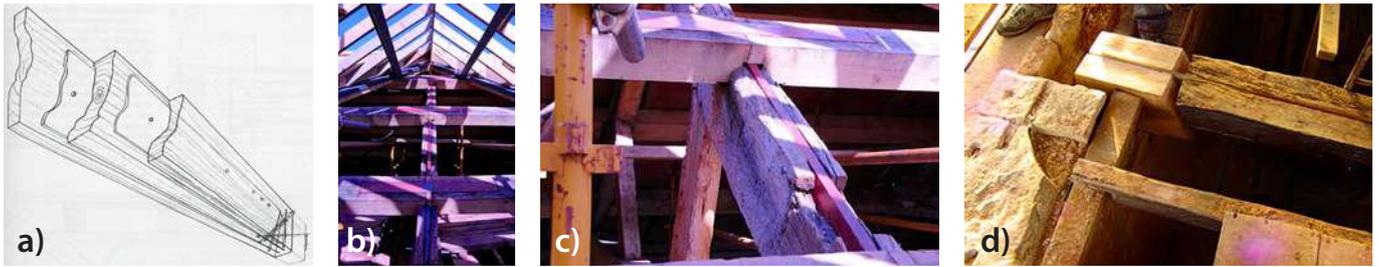
Fig. 6. Strengthening of a timber member by insertion of steel plates. Invention patent G. Tampone, L. Campa, 1987 (a) [12]. Barn (14th century) in Herefordshire, UK (Sinclair Johnston, 2009). Truss repair using a 20-mm thick steel flitch plate and resin. If resins were not used, many bolts would have been required, further cutting away the fabric and having less aesthetic appeal (b-d) [15].

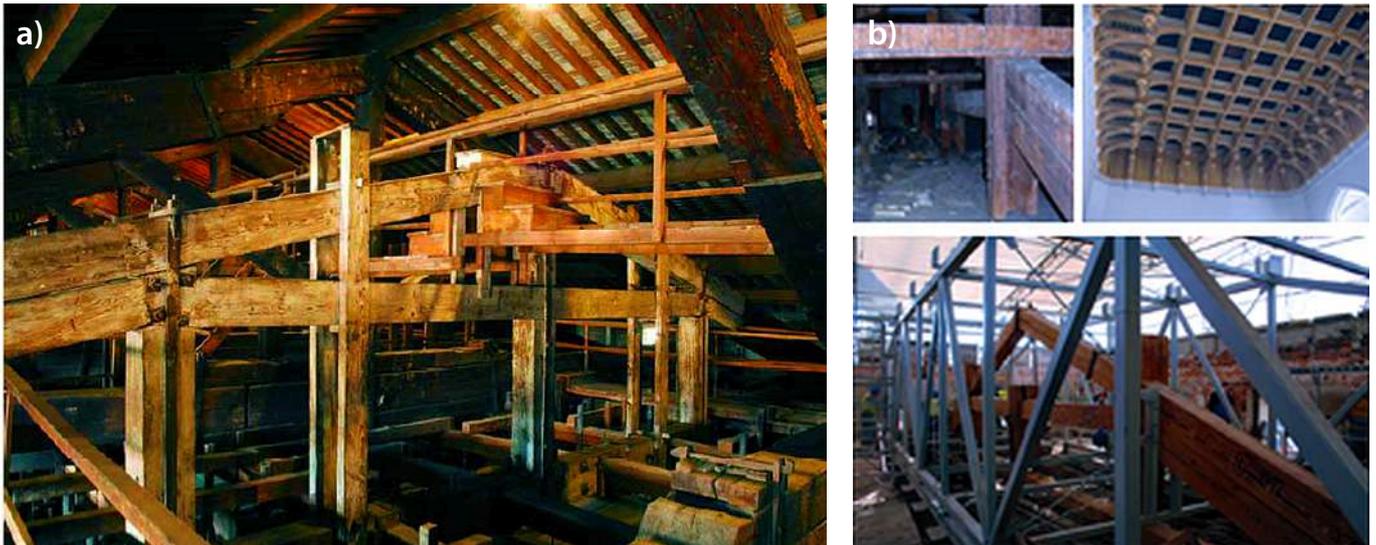
Fig. 13. Salone dei Cinquecento in Palazzo Vecchio, Florence. General view of the two trusses for the roof at the back of the photo (the original one) and the new one at the front (a) [25]. Main Railway Station in Wroclaw: A new load-bearing structure for the ceiling (a steel space frame) was used to relieve the roof truss from the coffer ceiling loads (b) [26].

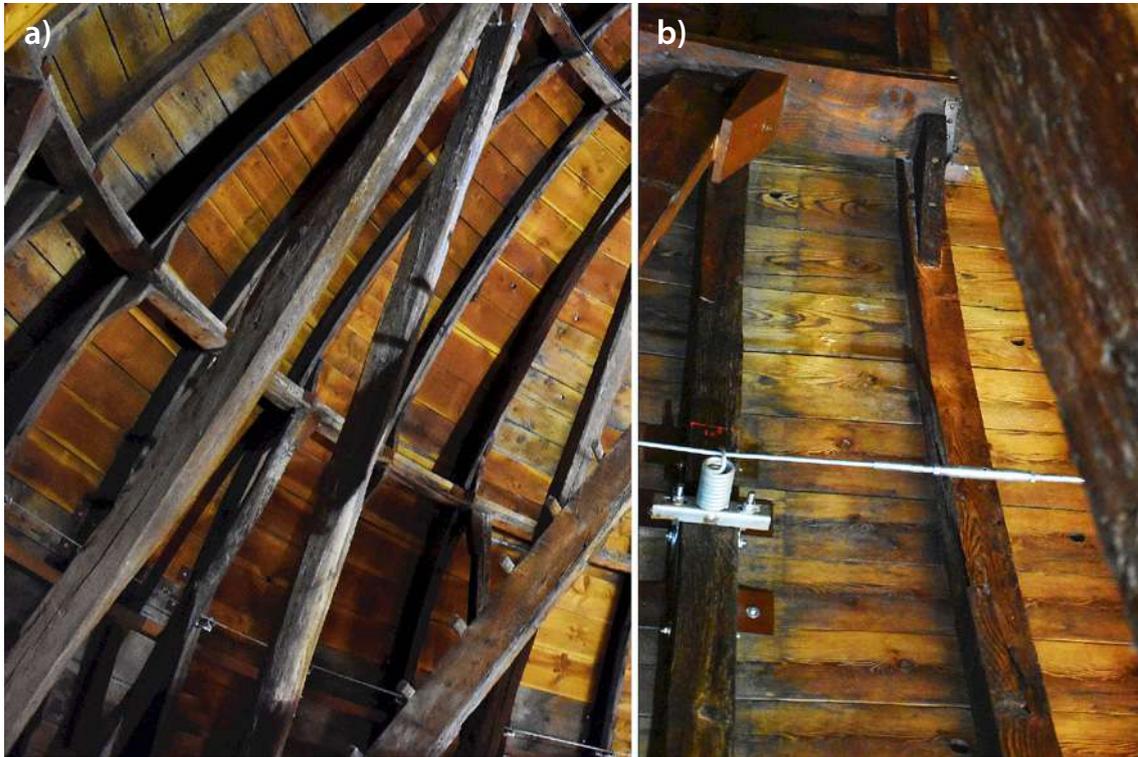
Fig. 6. Joints between ribs and rings: choir dome (a) and façade dome (b).

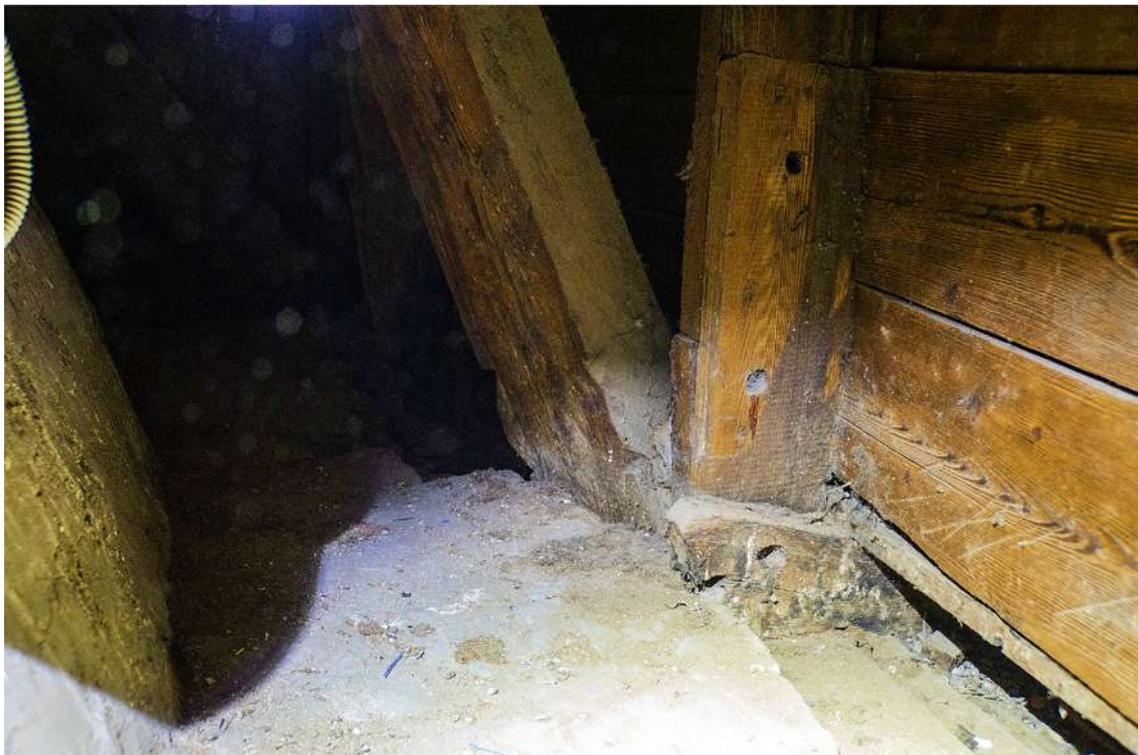
Fig. 7. Relics dome: cover plates supported by short wooden blocks to follow the projecting profile of the outer shell.

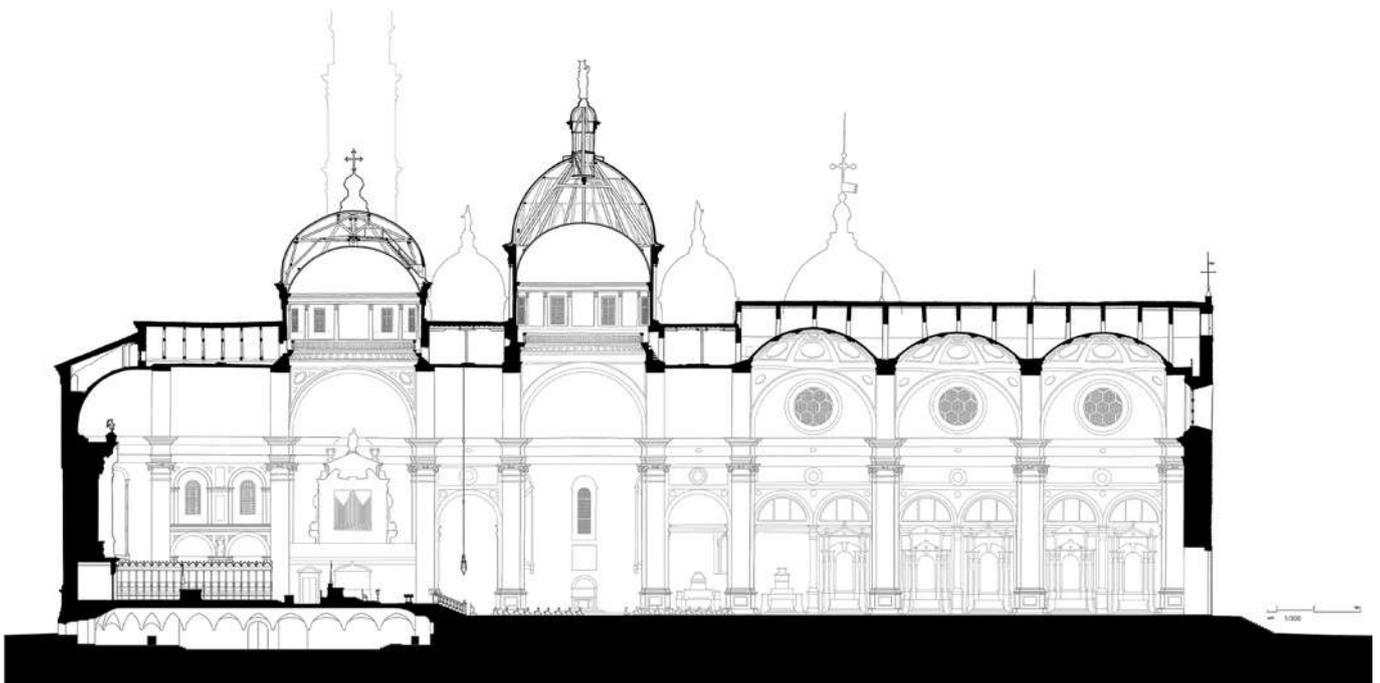
Fig. 9. St. Justine Abbey: longitudinal section. (Image source: photo courtesy of Pfister, 2022).

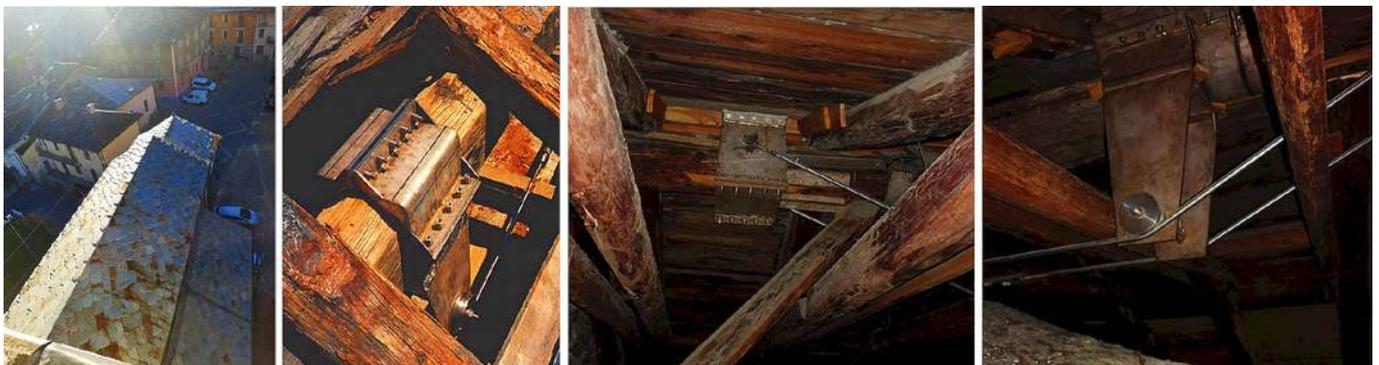
Fig. 11. Church of Salbertrand. From left: Images of the roof structure in 2000 with the small portion of the roof that was opened during the intervention works, some details of the steel elements of the reinforced beam. Images of the roof cover with stone slates and the roof structure in 2021. (Image source: courtesy of N. Faure and R. Casse).
